# Conservation problems of rural architecture: A case study in Gölpaşarı, Anatolia

## Abstract

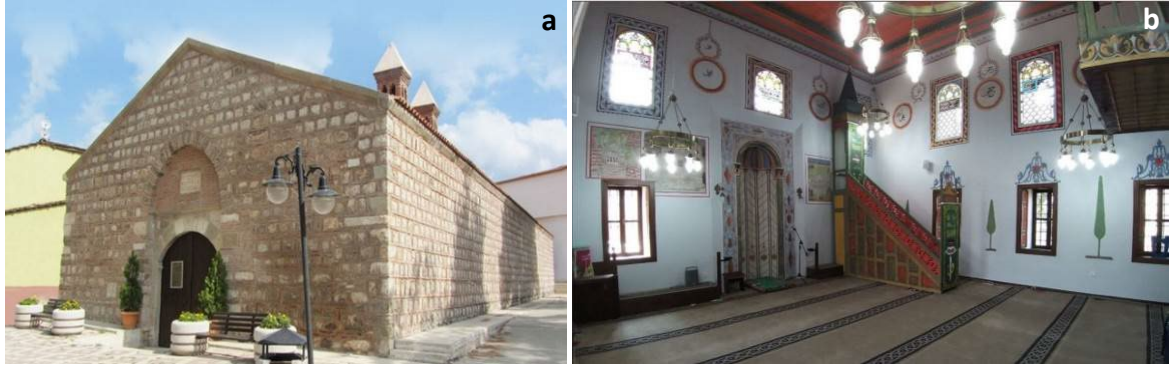
**Figure 5a** Mihal Gazi Caravanserai 15 th century (photo:authors); **b** Kasımlar Mosque-17th century (photo:H.Yıldız).

The settlement has an active transportation network between Bilecik, Sakarya, and Bolu cities. Trade and transportation axes form the nodal point in the district center; Mihal Gazi Caravanserai (Figure 5a), Mihal Gazi Mosque, Turkish bath, and Zincirlikuyu are important monumental buildings at this point, dating back to the 1400s. These structures are the focal point of the district and the streets in organic form converge at the center (Figure 4). The Kasımlar Mosque (Figure 5b) dated to the end of the 17th century in Kasımlar Village, the Byzantine bath, and church ruins in Bolatlı Village are important monumental values. There are many archeological ruins, tumulus and architectural structures in the villages of Gölpaazarı (Figure 2).

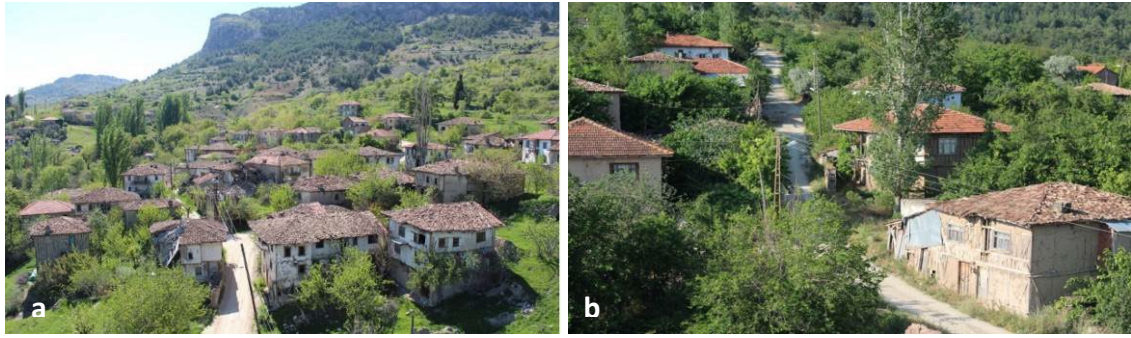
**Figure 6 a** Büyükbelen Village; **b** Keskin Village (photo:authors).

The rural architecture in the villages consists of one or two-story houses, one-story barns, warehouses, and hayloft structures (Figure 6). In the district there are new constructions with the reinforced concrete system together with traditional structures. The traditional buildings were limited to a maximum of three floors, and the ratio of these three-story buildings (including built with the reinforced concrete system) to the number of whole buildings in the district center is 9% (Table 1).

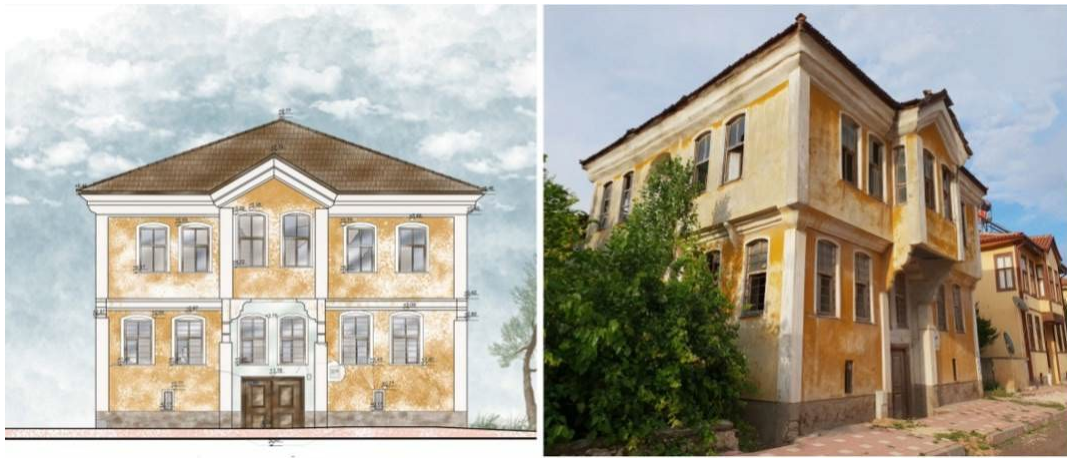
Figure 9 Kadioğlu Pavilion survey drawing and 2019 photo (authors).

Gölpazarı has monumental buildings belonging to the early Ottoman Period as well as important pavillions dated to the last period of the empire. Kadioğlu Pavillion is known as a historical place belonging to the late Ottoman period and where the Kadi (Muslim judge) of this period lived, but today it is abandoned (Figure 9). It was observed that the houses examined in the region were built in the plan type with inner and corner/edge sofa according to the Turkish house plan tradition (Figure 10). The sofa is a space that meets many functions required by daily life such as eating, cooking, resting, sitting, and welcoming guests (Kâhya et al., 2018). In the plan type with an inner sofa, rooms are lined up on both sides of the sofa. In some types, it has been expanded by adding a stair or a side sofa (Eldem, 1954). The corner sofa plan is the type with the sofa in the corner and surrounded by rooms on two sides and other sides open to outside with windows or an entrance gate. The plan type with side sofa was encountered before the 19th century in Anatolia. Inner and central sofa plan types became widespread in the 19th century as vertical and transverse symmetrical (Günay, 1999, 62).

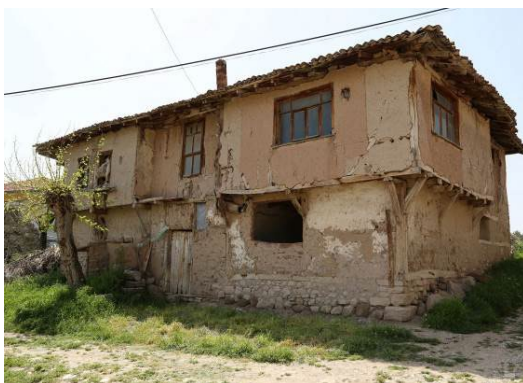
**Figure 11** A house in Tongurlar Village

It is noteworthy that all of the traditional buildings have a characteristic facade arrangement in the region, although their functions are different (residential or residential and commercial). The front facades of the houses have more specific feature with their symmetric layout and projections. The main entrance door was located in the middle and the windows were arranged symmetrically to the door on the façade. The central projections on the entrance doors emphasize the symmetry of the facade and the plan type of the inner sofa (Figures 8, 9 and 11). In houses with barn or woodshed on the ground floors, these facades are deaf and have narrow windows, while the layout changes on the upper floors (Figures 8, 9a and 10). Thus, the functions of the floors are perceived from the facade. The facades were generally undecorated and plastered; however, wooden floor beams, vertical posts on the corners were left exposed (Figures 9a and 11).

Projections are common architectural elements on the frontage as a balcony or alcove (Figures 8, 9 and 11). In some houses the top of the projections were arranged to form a triangular pediment (Figures 8 and 9). They were plastered or wooden covered; however, it is highlighted by a wooden floor cornice. The side facades of the projection with little depth not have windows or there are narrow windows.

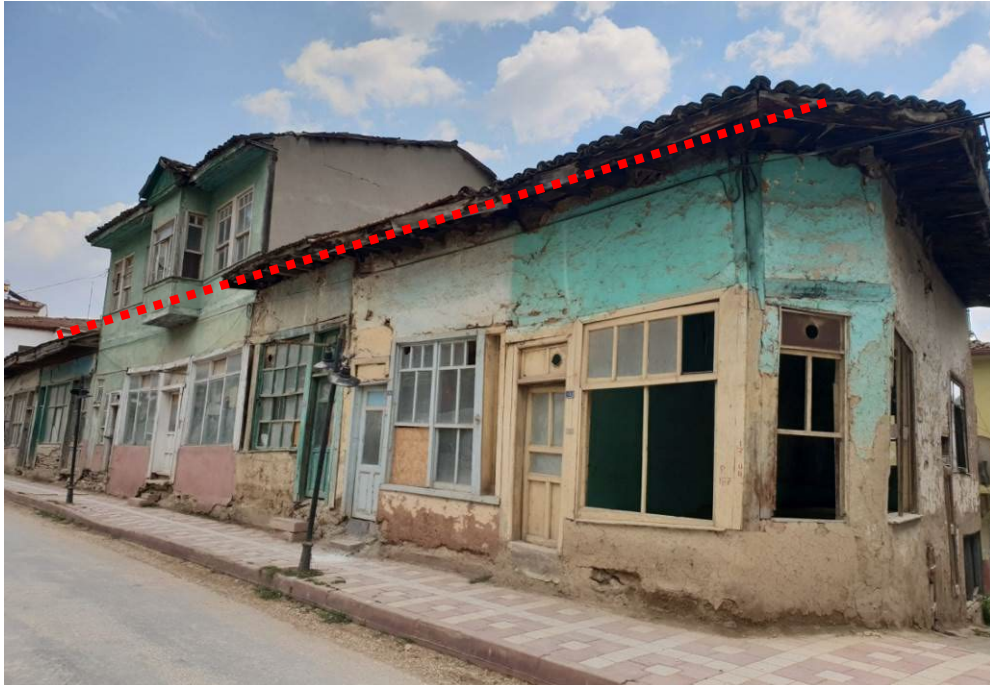
**Figure 13** Facade arrangement in adjacent buildings (photo: authors).

While the building facades have symmetry and order in themselves, it is another important architectural feature that the structures in the neighboring parcels were also designed in harmony. In adjacent structures with the same number of floors, a building cornice continued to the side building, and they were covered with a single roof cover. As it can be seen in Figure 13, when a two-story building was built next to a single-story building, the eave cornice of the existing building and the floor cornice of the two-story building were arranged in harmony. The roofs were planned together and arranged with gable roofs.

Not only in eaves and cornice arrangements; it is remarkable that the buildings in the neighboring parcels continue the facade features of each other, have a similar gauge, occupancy-space, and symmetrical window arrangements. This feature shows that harmony in the settlement texture. Living, producing, and sharing in Anatolia are well-known traditions from past to present; seeing the traces of the tradition in architectural features is magnificent.

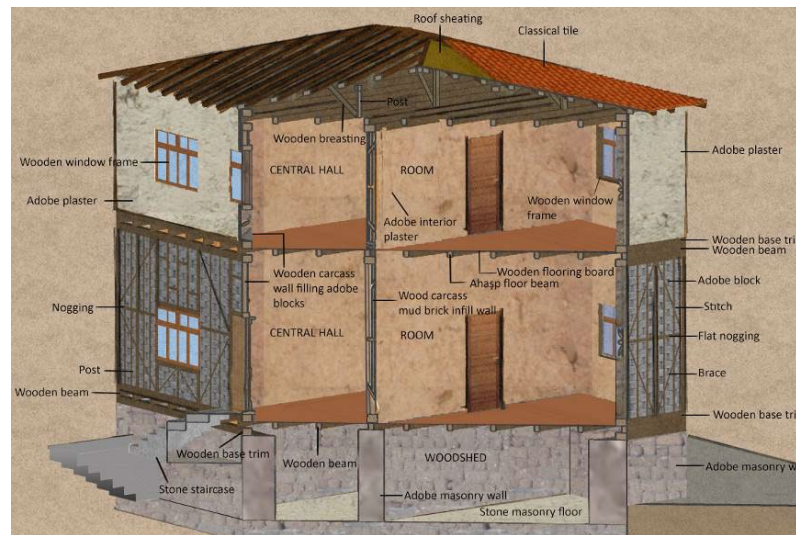
**Figure 14** "Hımsı" construction technique and building formation (illustration: authors).

In Gölpazarı the most common construction system is "hımsı" with adobe blocks. The main wooden pillars extended to the level of the floor slab and were supported by the head beam. Wooden lintels were used to prevent the props from bending against the vertical load. The adobe blocks were placed between the wooden elements in horizontal and diagonal form. The wall and floor beams were planned together in the wooden frame system. The door and window openings in the buildings were also arranged with wooden pillars, upper and lower braces. The locations of the main pillars and diagonals were determined according to the openings (Figure 14). The projections and balconies were extended outwards with wooden floor beams and supported by wooden buttresses. A frontal board covers only the wooden beams on the projections or continues along the entire facade (Figure 10); the construction systems were left open under the projections (Figures 11 and 13).

The adobe render applied as a surface coating to protect the system against climatic conditions. The clay in the plaster has advantageous water resistance as well as its nature (Figure 14). All roofs, which were arranged as hipped or gable roofs were covered with tiles do not have a rain drainage system, and the wooden elements used on the roof were not planed, but simply trimmed (Figures 10 and 13).

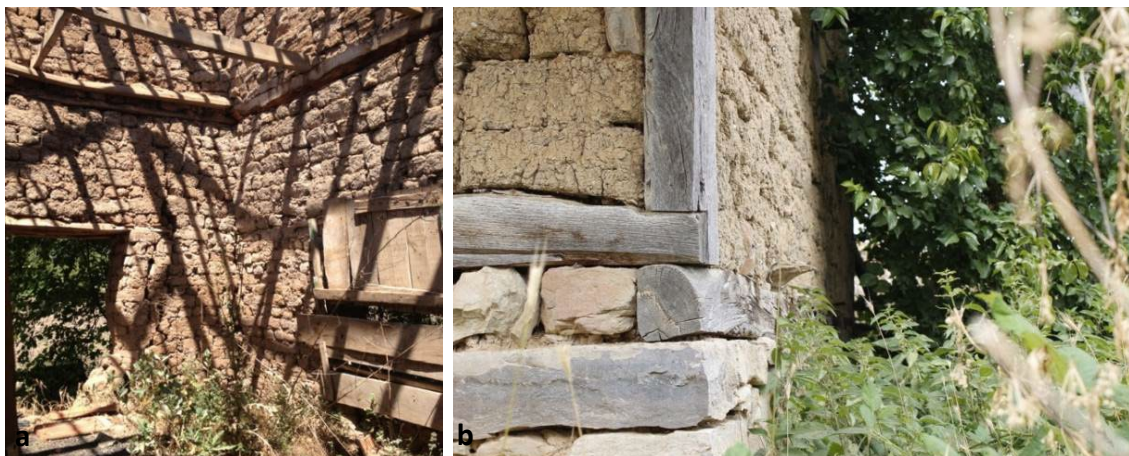
**Figure 15** A Wooden beams and adobe blocks b Structure details in adobe system (photos: authors).

The warehouse or barn structures were built with adobe masonry system and the interior walls were not plastered. The dimensions of the adobe blocks are differed; it is seen that the blocks were cast into molds of different sizes. Some houses also built in this system with two or three floors; the adobe walls were connected with wooden beams (Figure 15a). The wooden pillars were used at the corners of the building to strengthen the system (Figure 15b).

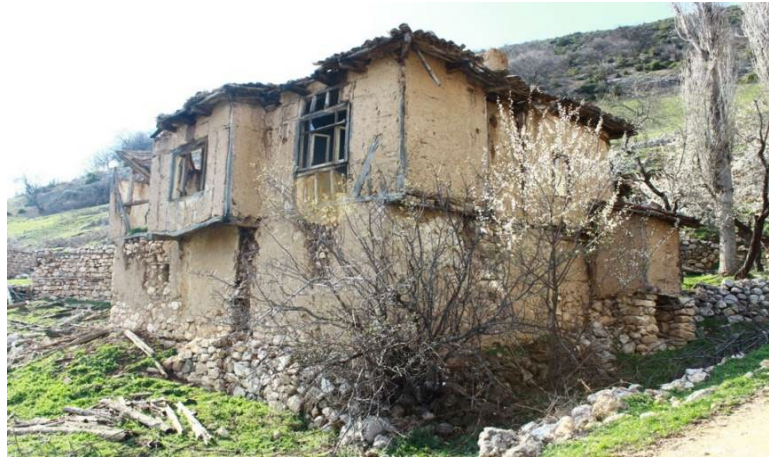
**Figure 16** An abandoned village house (photo:authors)

When buildings which have traditional construction system are left and unattended, the damage caused by the climate and external conditions cannot be followed. If not intervened in time, the extent of the damage increases and these structures are about to collapse (Figure 16). It is observed that the mudbrick plaster has been poured into the buildings that had been neglected and not

intervened in the settlement; the wooden frame is exposed to climatic conditions, and the damage progresses in the construction system and undergoes severe structural deformations.

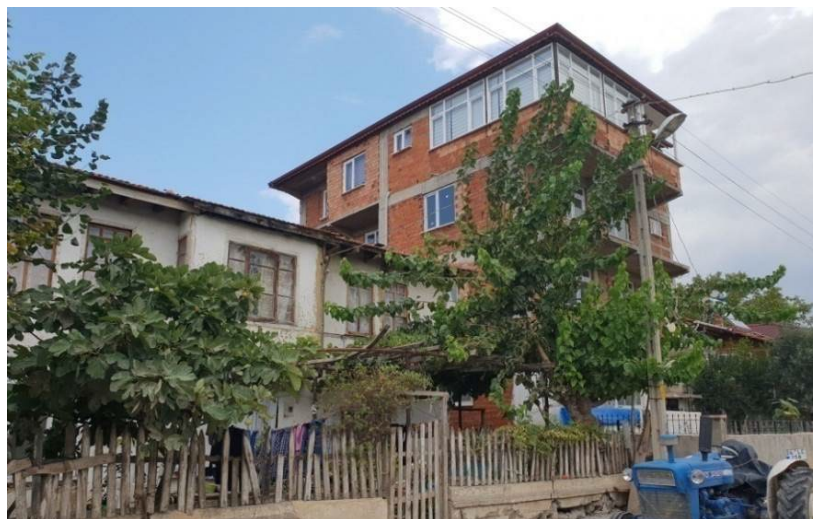
**Figure 17** A multi-story building next to the house built in hıms technique (photo:authors)

The increasing number of multi-stories reinforced concrete structures in the settlement almost overwhelm the traditional low-rise buildings (Table 1 and Figure 17). The facade order and harmony of the traditional houses were not even considered as a planning decision in new buildings; window and balcony forms that do not match the original architectural texture. Moreover, each floor was arranged with different window proportions on multi-story buildings. These structures disrupt the architectural identity of the settlement with their completely different appearance and construction systems (Figure 17).

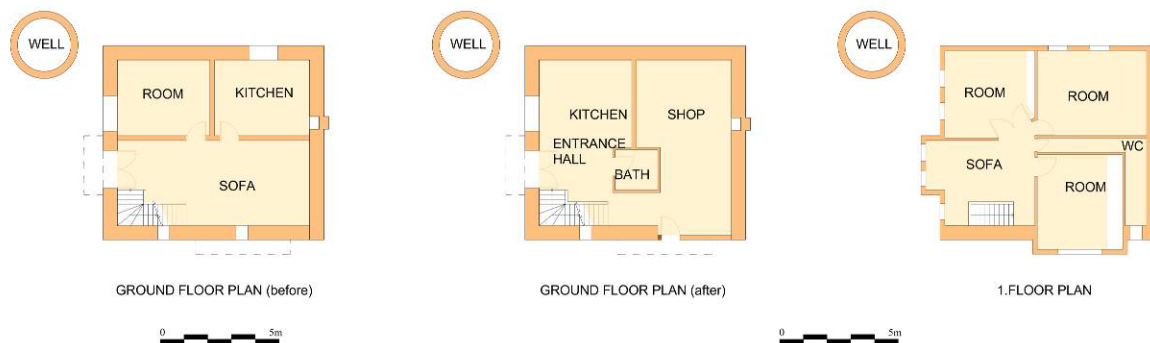
**Figure 18** The house with an edge sofa whose plan scheme was changed with the additions (illustration: authors).

With the changing living conditions, people want to live in comfortable homes and large spaces. Therefore, the owners of the houses unite the two rooms by removing the walls or build partition walls in the sofa spaces to have an additional room. In some houses, the ground and first floors were used for different purposes or different users; rearranged the spaces, and wet areas were added to the floors; thus, the plan has become incomprehensible, and sofas have lost their characteristics (Figure 18). These interventions not only change the plan typology of the buildings but also affect the structure. The room walls of the original structure of the building are not only dividing walls but also a part of the construction system as being bearing walls. With the removal of these walls, the structural balance of the building is also disrupted.

In the region, the plan type with a corner sofa is generally seen in square planned structures. Since these structures have narrow interiors, sofas have been converted into rooms or kitchen spaces and have become imperceptible (Figure 18).

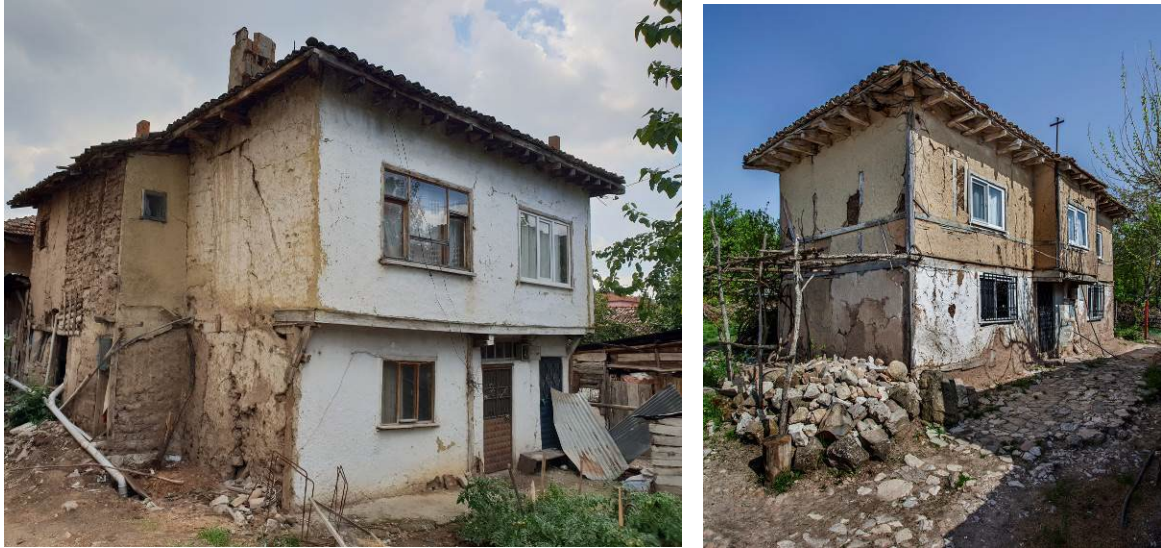
**Figure 19** PVC joinery and iron door renovation in houses

The modern building materials are preferred in the repairs of traditional buildings because of their rapid availability and the insufficient recognition of conventional building materials. The traditional roof cover in the region is pantile, but during roof renovations, they partially or completely replaced with Marseille tile. In houses, it is common for the owners to renew their window joinery with PVC and entrance doors with iron doors. With the use of PVC joinery in buildings, the facade feature of the building changes completely. Depending on the needs, the window joineries were renewed partly, and then all were replaced (Figure 19).

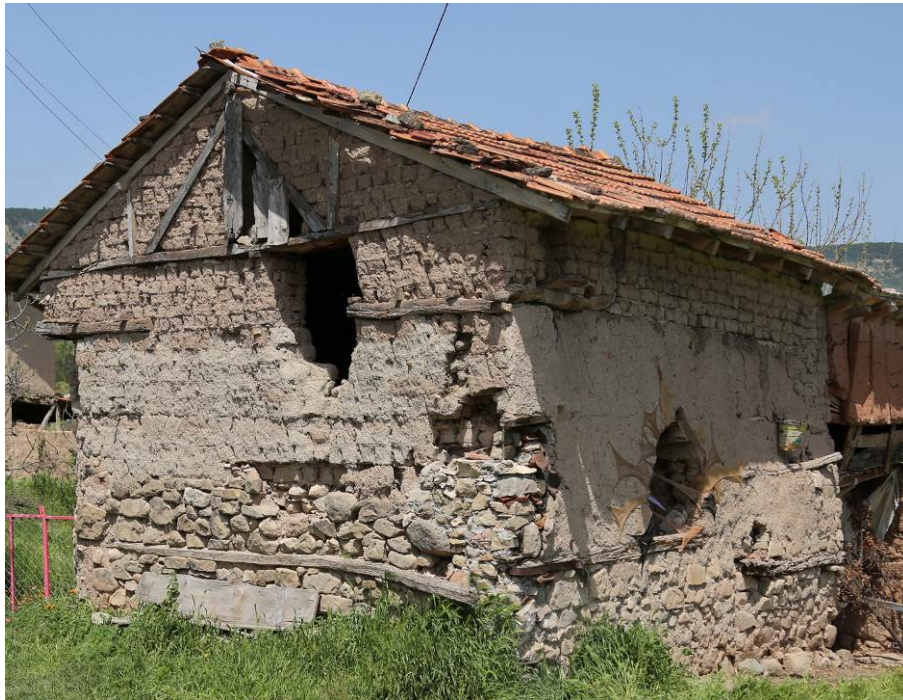
**Figure 20** Cementitious repair on the masonry wall and rendering (Keep Your Village Alive Project).

The sustainability of the adobe is difficult, which is the common construction technique of the region, so repairs were carried out with cement-based materials in plasters and masonry walls. Compounds in cement are not compatible with the original building material. Also, due to its rigid structure prevents the building from breathing; thus, dispersions occur in the building material (Figure 20).

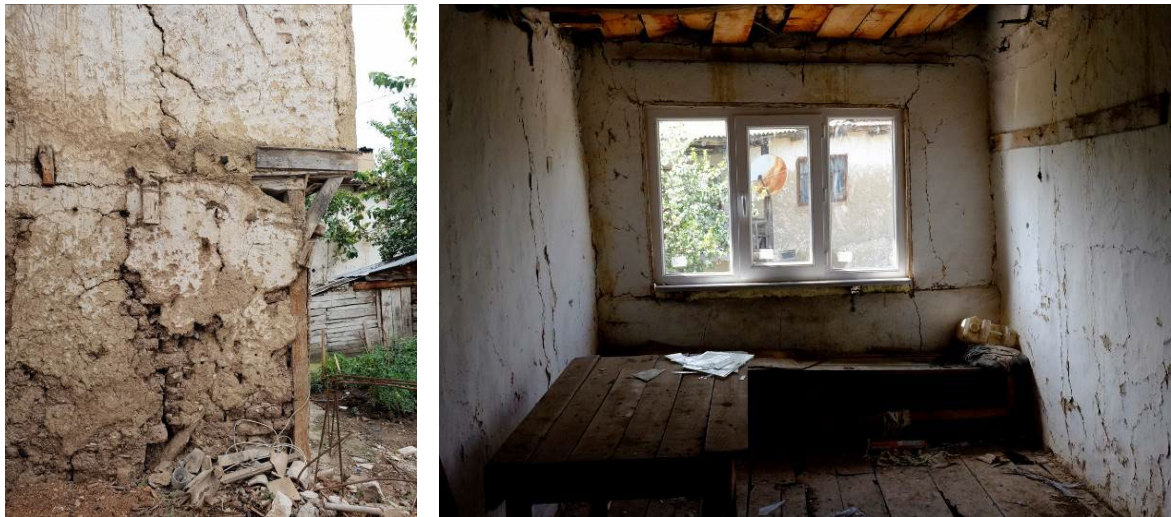
**Figure 22** Damages in the buildings

In many buildings in the study area, the adobe material was not repaired by traditional methods, it was intervened quickly and indiscriminately with different materials. Especially the number of buildings that are severely affected by the water coming from the ground with capillarity is in majority. In this case, the water penetrating causes faster structural damage in the masonry system and wooden frame. Irreversible losses occur in the buildings, especially in abandoned, since the type and progression of the damage cannot be determined. There are many buildings in the villages with damaged and collapsed roofs. Due to the loss of plaster on the facades because of the wind, temperature differences or humidity, the building remains open to external weather conditions. The filling mortar between the adobe blocks has lost and the blocks are deformed.

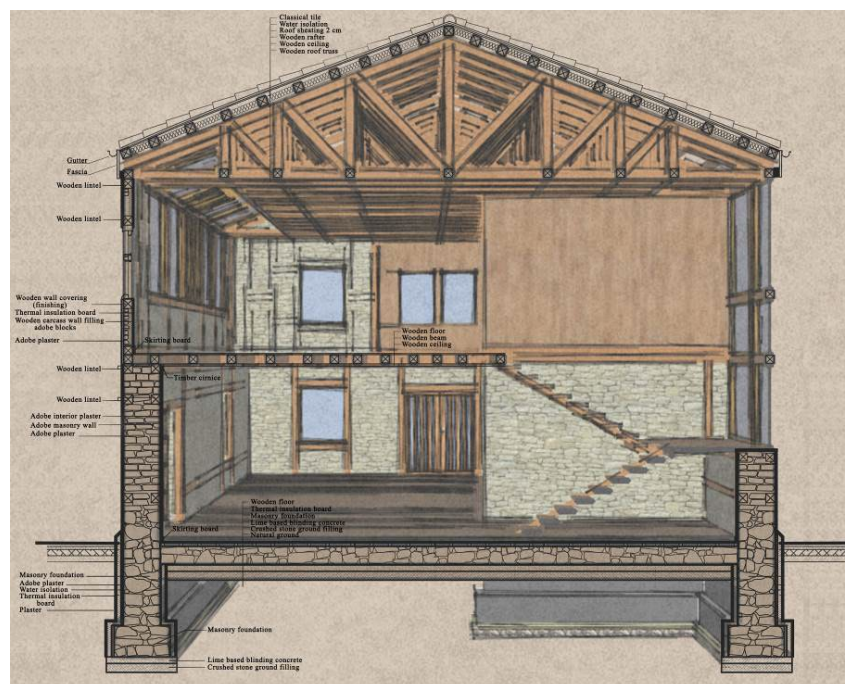
**Figure 23** System section proposal that can be used in buildings to be restored (illustration: authors).

- Heat loss could be reduced by applying thermal insulation board between rafters or on ceiling boards during roof repairs (Figure 23). In buildings with wooden frame and lathed wall systems, energy efficiency on the building walls could be increased by placing suitable thermal insulation material (e.g., extruded, expanded polystyrene, rock wool foam...) inside the frame for comfort condition.

- The facade transparency rate in the traditional buildings has been determined between 35% and 45% in the settlement, and the house owners stated that they were satisfied with the sunshine in their houses. Therefore, original wooden joineries could be redesigned with double-glazing, and thermal comfort conditions could be improved (Figure 23).
