# Swallowed by the urbanization: Spatial evolution of Adana Bağlarbaşı District

**Keywords:** Adana vineyard houses, Bağlar, rural architectural heritage, urban morphology.

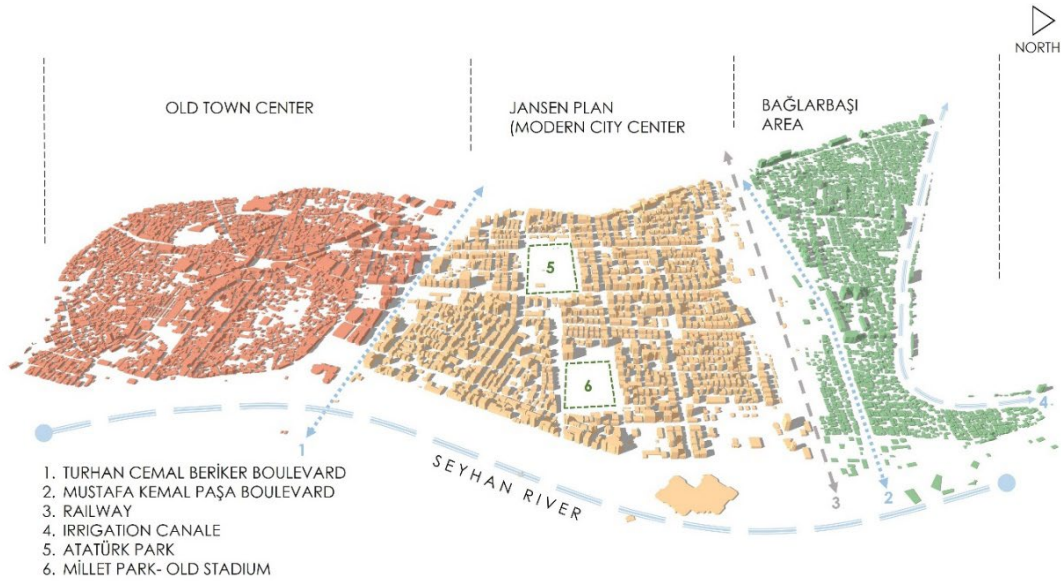
**Figure 2** The current relationship between the historic city center of Adana, the built-up part according to the Jansen Plan and the study area (Bağlarbaşı area) of this article (produced by Aytaç Taşkın).

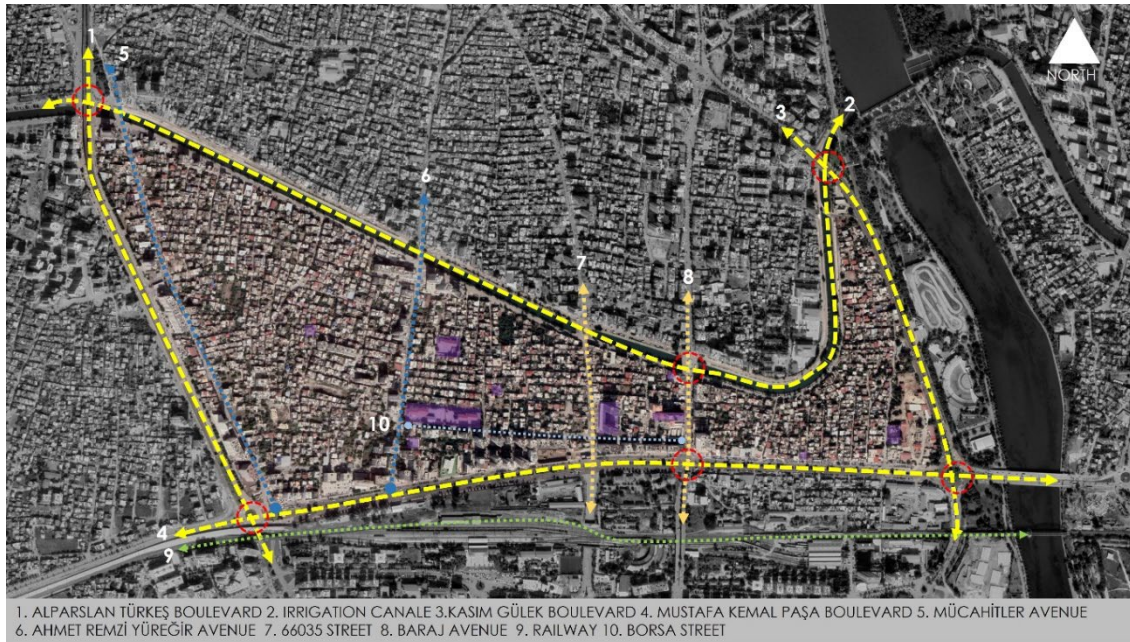
Figure 3 Lynch Analysis (produced by Aytaç Taşkın).

Gazipaşa, Ziyapaşa and Namık Kemal Neighborhoods in Seyhan District of Adana, which have been in the process of urbanization since the 1950s, were located on the outskirts of the city when they were first formed. The current borders of the neighborhoods are quite old. The south of the three neighborhoods is bordered by the Adana Mersin railway line. This border has not changed since 1911 when the new Adana train station was put into service (Şenyiğit, 2002). The eastern border of Ziyapaşa Neighborhood in the east of the area is the Seyhan River. While the border of Namık Kemal Neighborhood in the west of the area was the street known as Karaisalı Road, which is now called Mücahitler Street. Alparslan Türkeş Boulevard was opened to the west of the street as a result of the metro works that started in the 1990s, and the boulevard and the metro line became the western border of Namık Kemal Neighborhood. The irrigation canal, which is the northern boundary, is visible in the 1940 aerial photograph and the Jansen Plans, although the exact year of its construction cannot be determined. Therefore, the boundaries of the three neighborhoods were completely finalized in 1940 and there have been no major changes in these boundaries until today. Ahmet Remzi Yüreğir Street and Baraj Street, which form the boundaries between the neighborhoods, consist of the traces of the axes reaching to the historical city center as understood from the 1918 survey map. Today, Ahmet Remzi Yüreğir Street is interrupted by the railroad line, and 66035 Street was interrupted for many years for the same reason, but it was reunited with its historical axis with an underpass from Atatürk Street (Figure 3).

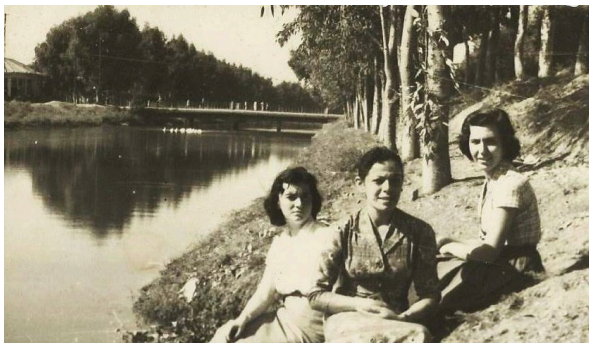
a. Eucalyptus trees on Kıyıboyu Avenue, 1950s.

When old aerial photographs and photographs are analyzed, it is seen that in the 1940s and 1950s, the irrigation canal located on the street known today as Kıyıboyu Street had a soil surface and double rows of eucalyptus trees were planted both to the north and south (Figure 4a). The 1950 aerial photograph shows that there are bridges known as Cemalpaşa Bridge and Kanalköprü at both ends of the area (where Karaisalı Road and Baraj Street intersect with the irrigation canal). Therefore, it is clear that these bridges were built before 1950. Figure 4a and Figure 4b show Cemalpaşa Bridge. In the 1960s, it is understood that the trees around the irrigation canal were cut down and the ground of the irrigation canal started to be covered with concrete (Figure 4b).

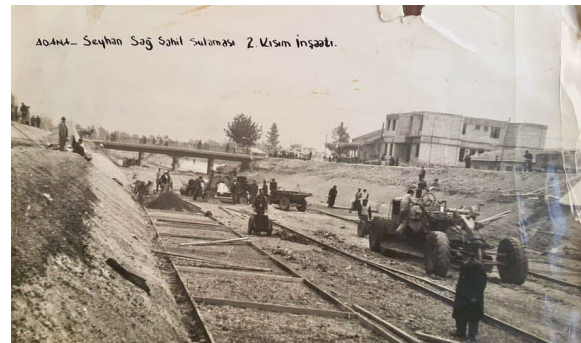
b. The process of concreting the irrigation canal, construction of Cemalpaşa Bridge and Bağlar Police Station, 1960s.

In the 1960s, Bağlar Police Station was built, named after the residential identity of the area. Figure 4b shows a photograph of the police station under construction. According to the memoirs of Zeki Gümüş (2018), the police station was established to eliminate public order problems in Bağlar area as a result of the increasing population.

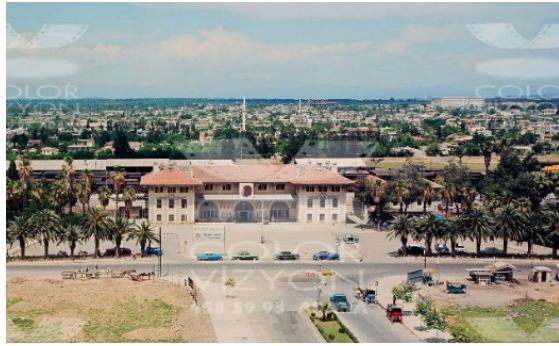
c. View of the Bağlar area from the Kurtuluş neighborhood, 1970s.

When the 1973 aerial photographs are analyzed, it is seen that the Jansen Plan area is largely built up, with only two large parcels not yet built up. These two parcels are today the regional offices of the State Railways and the Postal Organization. A photograph taken from the location of these parcels is shown in Figure 4c. When the photograph is examined, it is noticed that the approximately 1.5-kilometer Bağlar area behind the station and the railway line is built up in a rural texture. Looking towards the horizon line, it is seen that the green texture continues intensely. According to Gümüş (2018), vineyard houses and vineyards continue from this region to the Taurus Mountains. Looking in the opposite direction from where the same photograph was taken, the difference in the quality of construction between the two regions is clearly visible (Figure 4d).

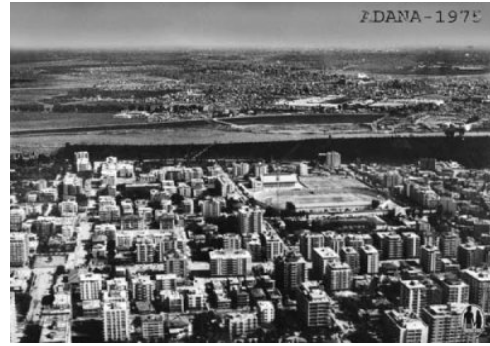
d. Jansen Plan Area, 1975.

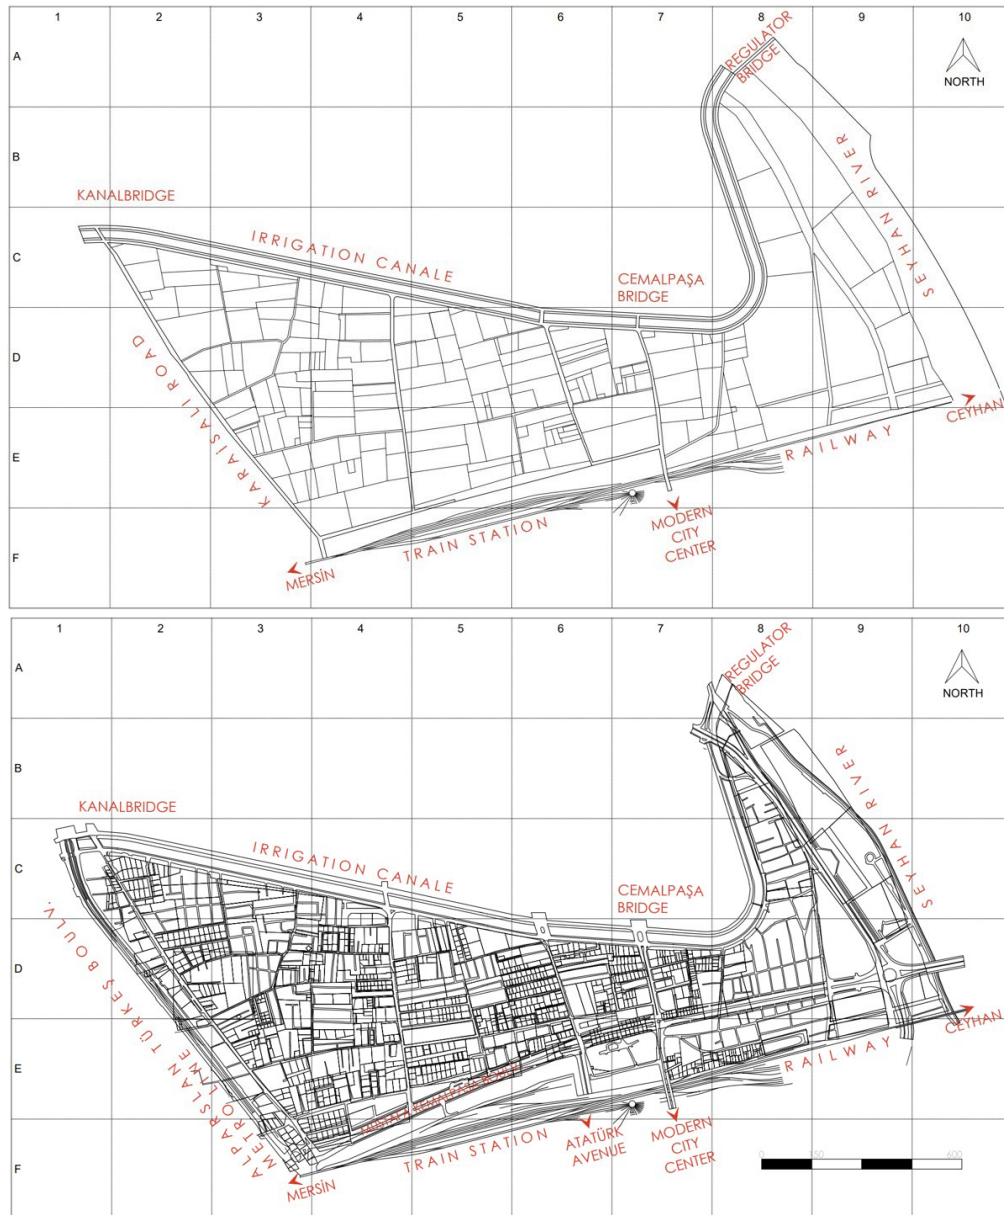
**Figure 8** Comparison of parcel sizes of Bağlar region between 1950 (top) and 2019 (bottom) (Produced by Aytaç Taşkın).

In 1950, there were 292 parcels in total in the Bağlar region. Although the parcel sizes vary, the average is 4200 square meters. Although they are few in number, some of them are under 500 square meters and the majority are over 500 square meters. There are also parcels whose size reaches 40000 square meters. 115 of these parcels are vineyards and houses, vineyards or gardens, 52 are fields, 64 are land plots, 13 are masonry or courtyard houses, the functions of the rest could not be determined. These parcels started to be divided since the 1950s and were sold first to relatives and then to people who migrated (Hız ve Göçük, 2018). In cases where no new parcels were created by dividing, shares were sold and houses were built in large parcels without a zoning or license. Until today, only a few parcels from the division remained. In 2019, it was seen that the

number of parcels was more than 3000 and their size decreased to 100 square meters. In Figure 8, the condition of the parcels before and after the division is shown.

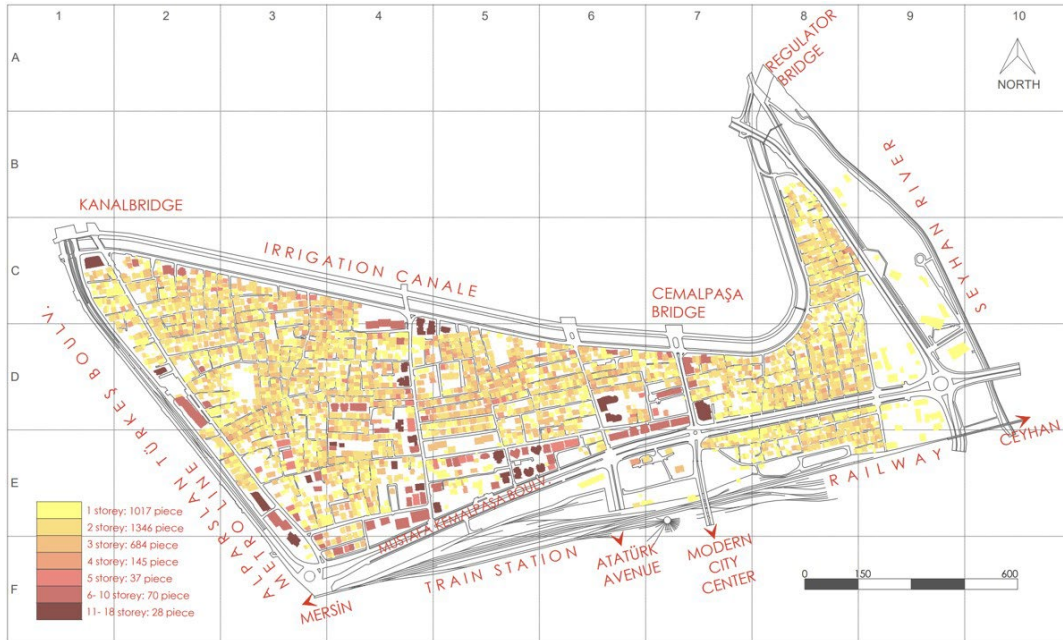
**Figure 9** Analysis of the number of storeys of three neighborhoods as of 2019 (Produced by Aytaç Taşkın)

There are a total of 228 buildings in the Bağlar region as determined from aerial photographs taken in 1950. As a result of the oral history studies conducted in the neighborhood, it was determined that the majority of these buildings bear the typical characteristics of the cottages presented within the scope of the study. By 1985, there were 1413 1-storey buildings, 1393 2-storey buildings, 56 4-storey buildings and 41 5-storey buildings in the neighborhood. Buildings over five floors are very rare and the maximum number of buildings is 11 floors. When we come to the present day, it is determined that the number of buildings has increased in parallel with the increase in population. The number of single-storey buildings is 1017, the number of two-storey buildings is 1346, the number of three-storey buildings is 684, the number of four-storey buildings is 145, the number of 5-storey buildings is 37, there are 70 buildings between 6 and 10 floors and 28 buildings between 11 and 18 floors (Figure 9).

When Figure 9 is analyzed, it is seen that the majority of the houses are between one and three storeys. The most important element that draws attention as a result of this analysis is the locations

where high-density buildings are constructed. When the diagram of the number of storeys analysis in Figure 9 is analyzed, it is seen that five storeys and above are built on Mücahitler Street, Baraj Street, 66035 Street, the continuation of Atatürk Street, Mustafa Kemalpaşa Boulevard and its surroundings. These axes correspond to the threshold, border and nodal points of the neighborhood. In the Ziyapaşa neighborhood, the situation is different. Since the eastern side of this neighborhood, which is close to the river, was declared an urban transformation zone in the early 2000s, therefore there is no high-density construction on and around Kasım Gülek Boulevard.

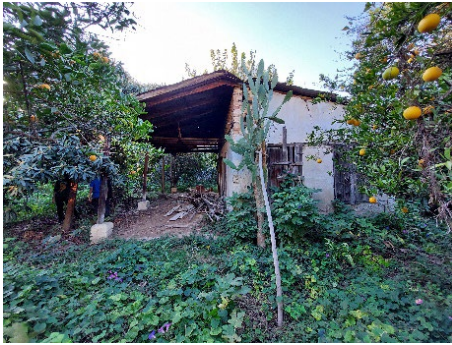
c. Cottage in Gazipaşa neighborhood, 2022 (Aytaç Taşkın Archive)

According to the examinations made in the study area, it was seen that the cottages that survived in Gazipaşa Neighborhood are mostly single-storey. Survey studies and interviews with the owners were conducted on one of these houses. Like the others, this house has two rooms around an open sofa and a hipped roof (Figure 10c, 10d). It was found that a bathroom was added to the building later, the parcel of the building was preserved and an orange grove was created. This cottage is an example of a rare, preserved parcel and building combination in the region.

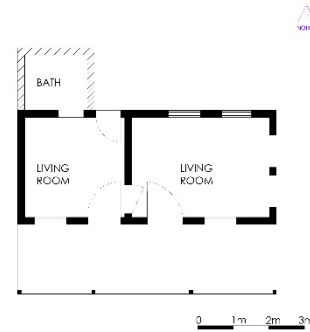
d. Cottage plan in Gazipaşa neighborhood, 2022
