# Diyarbakır Hasan Pasha Inn: A thorough evaluation of risk analysis and accessibility concerns

**Keywords:** Diyarbakır Hasan Pasha Inn, accessibility, risk analysis, cultural heritage, risk assessment

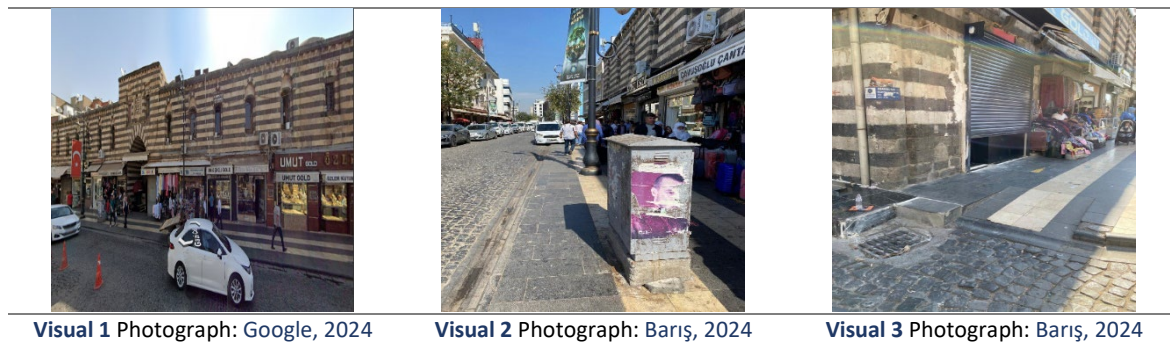
**Table 5** Hasan Pasha Inn's Immediate Surroundings

Hasan Pasha Inn has a strategic location in the historical Sur district of Diyarbakır province. Jewelers' Bazaar is in the south and east of the Inn, Süleyman Nazif Street is in the north, and Gazi Street is in the west (Table 5). Due to its central location, the Inn has three entrances: The main entrance is on Gazi Street (Visual 1 and 3), the other two are in the Jewelers' Bazaar. Located in the heart of the lively market area in the historic Sur district, the Inn's surroundings are always lively and lively. Since Gazi Street is one of the main roads leading to Sur, traffic density is high (Visual 2).

Due to the high density of both people and cars, the area surrounding the Hasan Pasha Inn is potentially hazardous. Crossing Gazi Street presents a serious risk, particularly for users wishing to get to the Inn's entrance. During this transition, the car accident risk score was evaluated as 15 (Table 6). Because of this high-risk score, immediate action is required. To improve crossing safety, it is advised that pedestrian crossings be equipped with both visual and auditory signals.

Another risk that jeopardizes user circulation is the store stands surrounding the Inn. Despite the possibility of accidents due to the presence of these stands, the risk score of 6 is still lower (Table 6). However, by taking these stands down, the risk can be avoided.

Uneven and broken sidewalks are a major concern. They don't just pose a risk to people staying at the Inn but also to anyone walking nearby. The cracked pavement and poorly placed lighting make it easy for someone to trip and fall. To prevent these kinds of accidents, the local municipality needs to step in and take care of the repairs and maintenance.

| Nr | ACTION | DANGER | AFFECTED GROUPS | RISK | RISK SCORE | MEASUREMENT |
|---|---|---|---|---|---|---|
| 1 | Getting to the Hasan Pasha Inn | Crossing Gazi Street | Visitors Employees Business owners | Risk of car accidents | 15 | Controlled pedestrian crossing |
| 2 | Arriving at the Inn and circling it | Store stands on sidewalks | Visitors Employees Business owners | Risk of hitting stands | 6 | Shop stands must be removed |
| 3 | Arriving at the Inn and circling it | Uneven and broken sidewalks | Visitors Employees Business owners | Risk of tripping or falling | 9 | Sidewalks must be repaired |

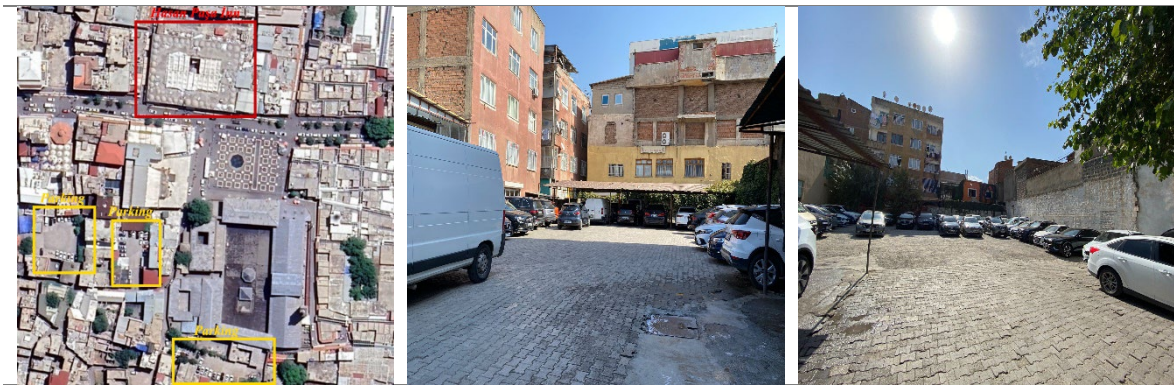
Table 7 The Connection Between the Parking Areas and the Hasan Pasha Inn

The Hasan Pasha Inn does not have a direct parking lot (Table 7). Parking around the Inn is nearly impossible due to the Jewelers' Bazaar's congested streets and narrow streets. The nearest parking lots to the Hasan Pasha Inn are 150–200 meters away, as shown in Visual 4. Even though there are private company parking lots close by (Visuals 5 and 6), access to these areas is made possible by the narrow streets. Due to this circumstance, drivers must cross unpaved and uneven roads to get to Gazi Street after parking.

Every user is seriously at risk due to the scarcity of parking spots near the Hasan Pasha Inn. When crossing Gazi Street to get to the Inn, drivers searching for a private parking spot may divert their focus from the road and pedestrians, which could result in accidents. Installing big, illuminated parking lot signs is advised to help avoid these kinds of mishaps. Drivers can reduce the risk and find parking spaces more easily in this way. Additionally, drivers must cross Gazi Street to access the Inn after parking. Pedestrians could be struck by cars during this transitional phase. This risk must be removed as soon as possible because of its high-risk score (15), (Table 8). This risk can be considerably decreased by establishing controlled pedestrian crossings.

| Nr | ACTION | DANGER | AFFECTED GROUPS | RISK | RISK SCORE | MEASUREMENT |
|---|---|---|--|---|---|---|
| 1 | Access by car | Driving and finding a parking space | Visitors<br>Employees<br>Business owners | Risk of car accidents | 15 | Signs indicating private parking spaces |
| 2 | Access by car | Crossing Gazi Street | Visitors<br>Employees<br>Business owners | Risk of car accidents | 15 | Controlled pedestrian crossing |

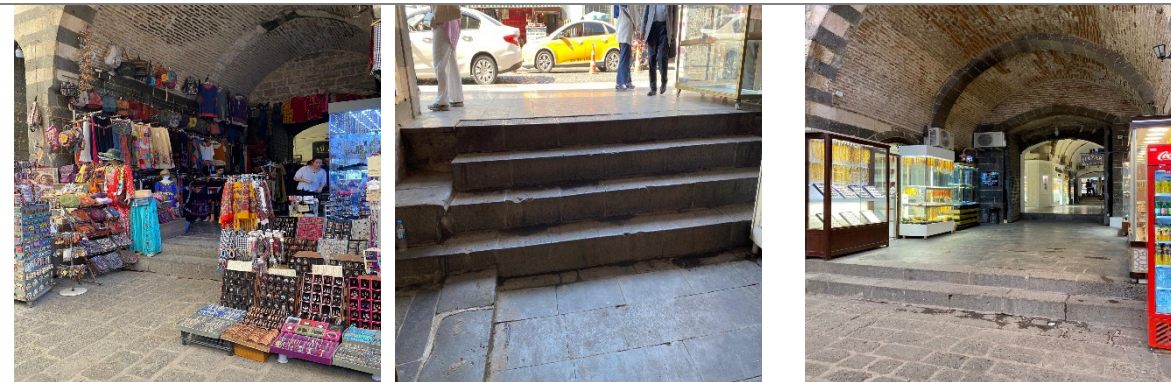
Table 9 Entrances of the Hasan Pasha Inn

The Hasan Pasha Inn features three main entrances. The most prominent entrance is situated on the west side of Gazi Street (Visual 8). Access to the Jewelers Bazaar is available through two entrances on the east and south sides. The east side gate, with its shop stands, is relatively small (Visual 7). In contrast, the south side entrance provides a larger space and a more gradual approach (Visual 9). The courtyard's ground level is lower than the entrances, and all these entrances lead to it. As a result, each entrance is equipped with stairs. However, the absence of ramps presents significant accessibility issues (Table 9).

The entrances of the Hasan Pasha Inn present several hazards (Table 10). The absence of ramps is a significant barrier, especially for underprivileged populations such as the elderly, disabled individuals, and families with infants. These individuals are unable to access the Inn due to the lack of accessible entrances. The stairs pose a high risk of falling, slipping, and tipping. To address this issue, an immediate solution would be to add a ramp to at least one entrance without compromising the historical structure's texture and aesthetics (Table 10).

When the basalt stones deteriorate and become wet, the absence of non-slip tape on the stairs increases the likelihood of slips. Applying non-slip tape to the stairs is a practical way to mitigate this risk. Additionally, the lack of railings at the entrances raises the possibility of falls and endangers all users. Therefore, designing and installing railings is necessary (Table 10).

The existence of commercial stands at the entrances poses a significant risk as well. These stands make the entrance area smaller and increase the risk of tripping and incidents. To avoid such hazards, the stands at the entrances must be taken down.

| Nr | ACTION | DANGER | AFFECTED GROUPS | RISK | RISK SCORE | MEASUREMENT |
|---|---|---|--|--|---|---|
| 1 | Entrance to the Inn | Lack of ramp | Visitors<br>Employees<br>Business owners | Wheelchairs and strollers tipping over | 12 | A ramp must be constructed. |
| 2 | Entrance to the Inn | Lack of non-slip materials on stairs | Visitors<br>Employees<br>Business owners | Slip and fall | 16 | There must be non-slip material on the stairs |
| 3 | Entrance to the Inn | Stands narrowing the entrance | Visitors<br>Employees<br>Business owners | Tripping and falling | 6 | Stands at entrances must be removed |
| 4 | Entrance to the Inn | Lack of railings | Visitors<br>Employees<br>Business owners | Loss of grip and falling | 9 | Railings must be installed |

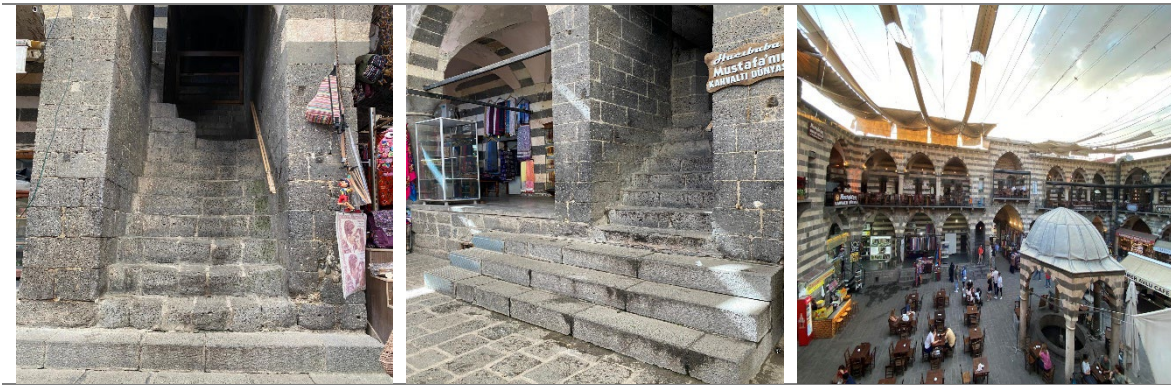
**Table 15** Horizontal and Vertical Circulation Visuals of the Hasan Pasha Inn

Buildings need to have both horizontal and vertical circulation to allow people to move around space easily. Since Hasan Pasha Inn has a 3-storey structure including the basement, it should be examined in terms of both vertical and horizontal circulation (Visual 18). Vertical circulation in Hasan Pasha Inn is provided by stairs, as seen in visual 16 and 17, but there is no elevator (Table 15). The effectiveness of the circulation system at the Hasan Pasha Inn is crucial for ensuring safety and meeting the needs of all user groups. The following section identifies the potential risks that could arise during circulation.

There are several risks for visitors at the Hasan Pasha Inn (Table 16). Because of the height variations on the steps, the vertical circulation stairs could pose significant risks. In the event of negligence, these variations may have lethal results. Therefore, posting warning signs on the stairs must raise awareness. An additional risk is also presented by the stairs' railings and the absence of non-slip tape. The installation of non-slip tapes and the installation of any missing railings are crucial steps in preventing these circumstances.
