# Rock-cut vernacular architecture in northeastern Kayseri: Architectural characteristics and conservation challenges

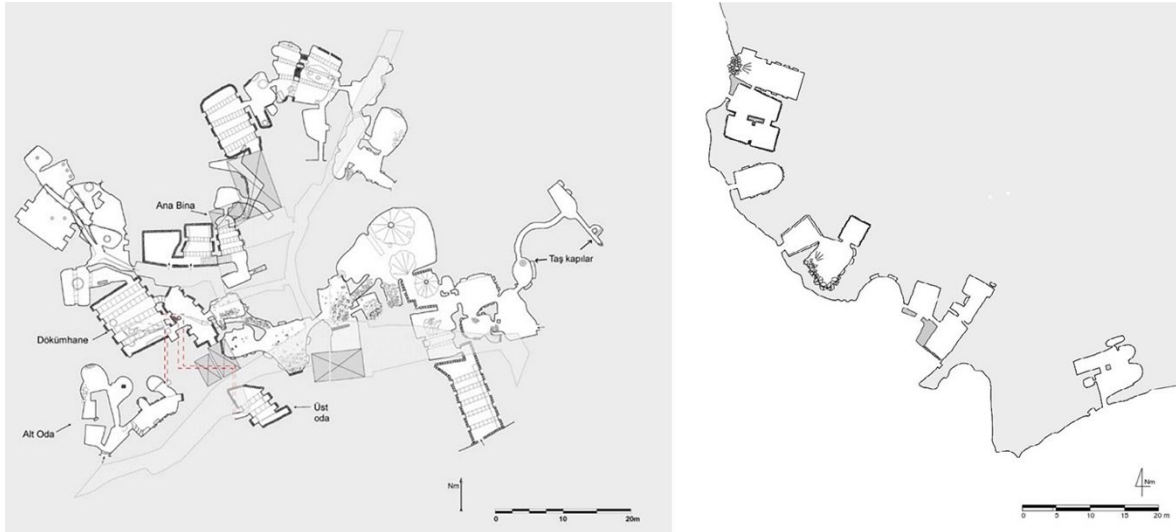
As a prominent example, Ağırnas Underground City illustrates both the defensive function and the multi-layered nature of these rock-cut settlements (Figure 2). Covering an area of approximately 1,850 m<sup>2</sup>, it features sliding stone doors, barrel-vaulted halls, storage spaces, and multi-level living areas typical of Cappadocian underground architecture. Excavation and cleaning works carried out between 2006 and 2008 led to the restoration and partial opening of the site to visitors. Today, the sections that have been cleared are accessible to the public, while other parts remain either unexplored or still locally used. This site vividly reflects the historical continuity of rock-cut habitation in the region (Yamaç, 2017).

**Figure 2** Left: Ağırnas Mimarsinan House underground city, right: Ağırnas north-east hillside rock carving settlement (Kayseri Büyükşehir Belediyesi, 2020)

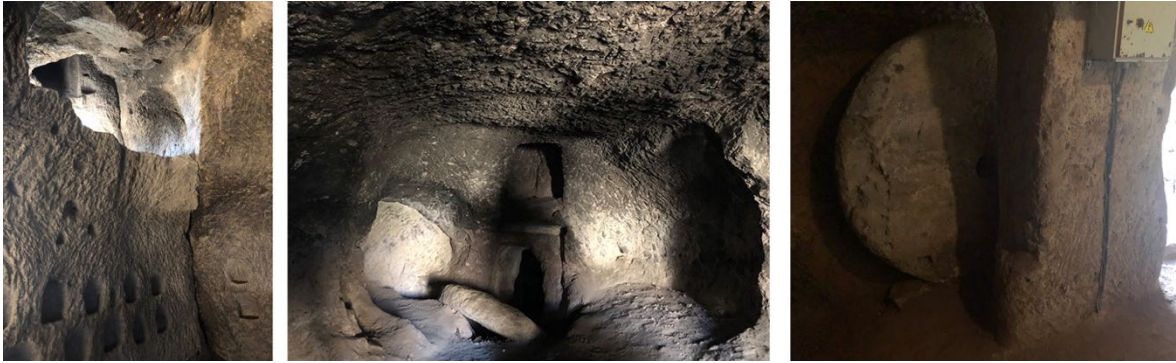
**Figure 3** Carving spaces under and back to the masonry houses (Bağpınar)

Spatially, these underground cities are organized into interconnected narrow passages and low tunnels that open into larger “salon” spaces, typically spread across two or three levels. Unlike hillside settlements, they have no facades visible from the surface and are accessed only through hidden entrances. Ventilation is provided through vertical shafts reaching the surface (Yamaç, 2023). Altogether, these underground complexes tell a vivid story of adaptation to defensive needs, life carved into the earth, and the layered coexistence of history within living settlement patterns (Figure 3).

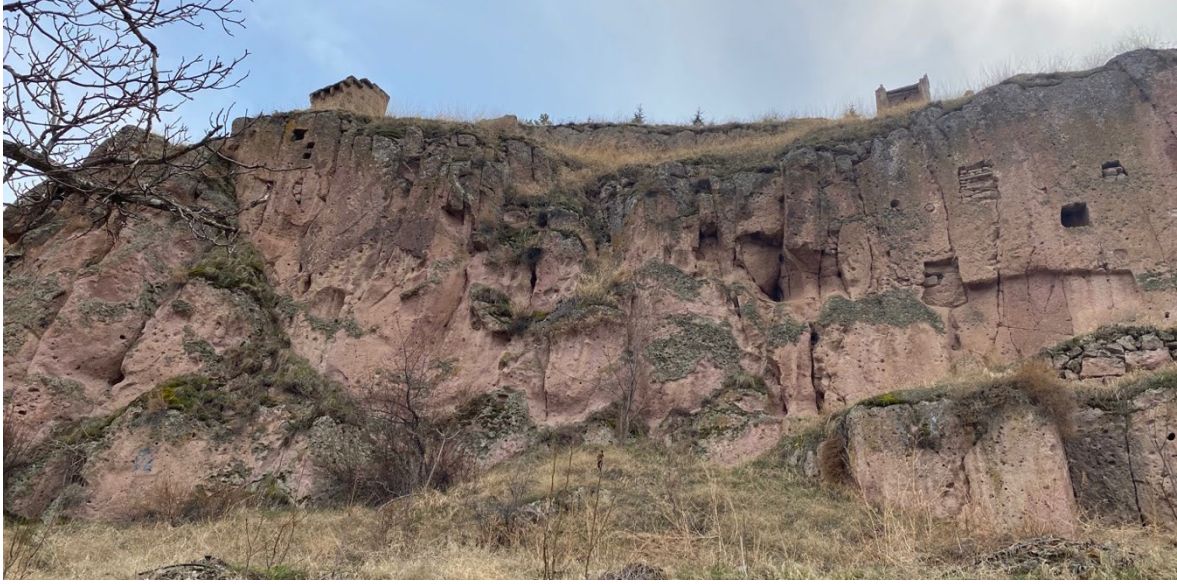
Building on the typological framework outlined above, the second major formation seen in the valleys includes hillside settlements or shelters, which developed along the steep slopes typical of the study area. Carved into these inclines, they feature outward-facing facades and demonstrate how dwellings adapted to the rugged topography. The tradition of hillside settlement continued in a way that closely resembled the layout of today’s neighborhoods until recent times. For centuries, most valley villages have been built on steep terrain, where modern houses often sit atop earlier rock-cut spaces, making it difficult to interpret their original purposes. Unlike underground cities, hillside settlements rarely have extensive tunnel networks; instead, short passages connect only a few interior spaces, with entrances opening directly from the valley’s surface. These entrances are located at different elevations along the slopes, usually above watercourses and terrace gardens (Figure 4).

**Figure 4** Rock-cut hillside shelters examples from Vekse (Koramaz Valley)

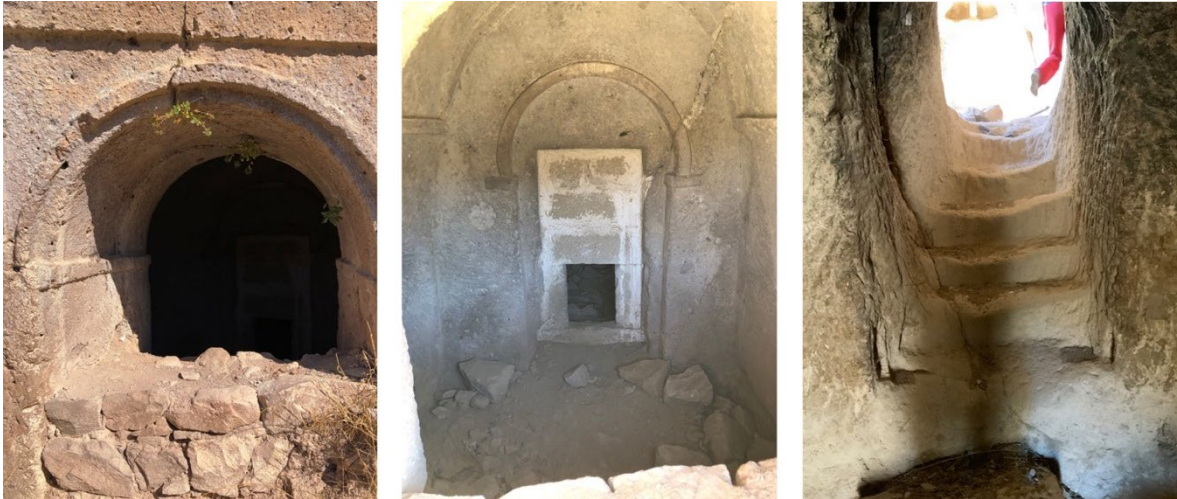
**Figure 5** Left and middle: Entrances of Değirmendere hillside rock carvings, right: Entrances of rock carving spaces (Bağpınar)

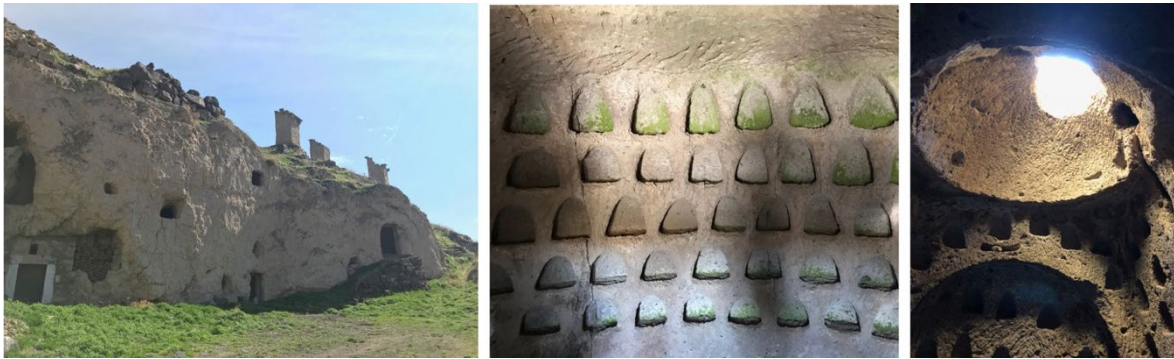
One of the most common structures in the valleys is the dovecote. Unlike similar examples elsewhere in Anatolia, these pigeon lofts evolved locally as specialized production structures adapted to the region's environmental and socio-economic conditions (Figure 6). They provide insights into agriculture, trade, and daily life during the Ottoman period, particularly through their association with vineyards and buckthorn cultivation, when dove manure had notable economic value (İnceköse, 2019). As water availability declined, pigeon breeding ceased, and the structures were abandoned, becoming prominent cultural landscape markers, especially in Gesi and Koramaz Valleys. Architecturally, dovecotes combine carved chambers with stone-masonry chimneys serving as bird entrances. Many former rock-cut spaces, including churches, Roman tombs, and columbaria, were later converted into dovecotes, complicating dating efforts and obscuring stratigraphic evidence (Yamaç, 2023).

Figure 6 Yeşilyurt (Mancusun) dovecotes, middle: Inside of dovecote, right: A changed carving space as dovecote (Kayabağ)

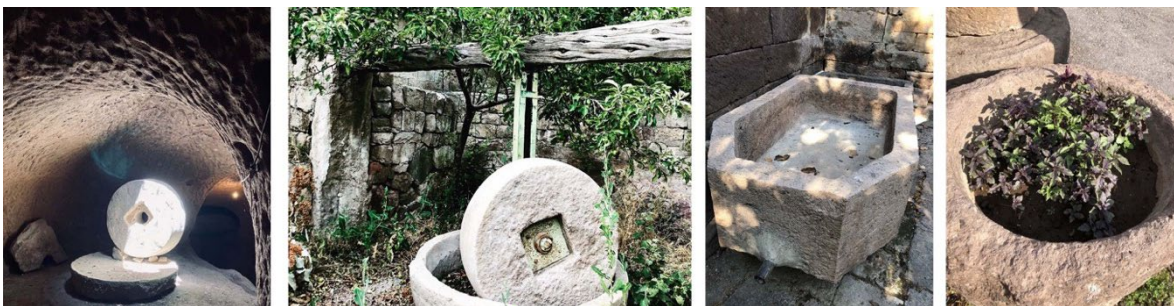
Documentation studies also addressed daily-use objects shaped from rock, illustrating the adaptation of natural resources to local production (Figure 7). These include animal-husbandry structures (barns, stables), plant-based facilities (dye houses, oil mills), and carved agricultural tools. Bezirhane processed linseed oil for food, lighting, and craft uses, while şirahane served as communal sites for molasses making. Tools such as seten (vertical millstone), soku (stone mortar), and dorak (dairy container) supported grain milling and dairy processing, reflecting how subsistence practices shaped rock-carving traditions (Kevseroğlu et al., 2021).

Figure 7 Left to right: Oil mill (Bezirhane), vertical millstone (Seten), stone basin (Sirahane), stone mortar (Soku)

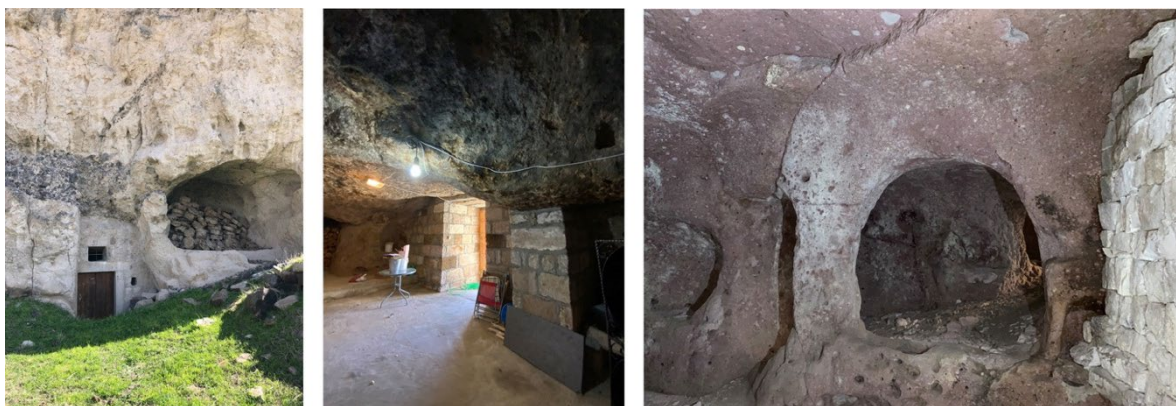
Figure 9 Hillside shelter rock-cut settlement relationship

Hillside settlements exhibit a morphology that extends the tradition of rock-cut slope dwellings. Contemporary masonry houses are built atop or adjacent to earlier carved spaces, resulting in a hybrid typology. These houses often incorporate “in” spaces, rock-cut units, independent or shared, divided by masonry walls. Cubic masonry structures are aligned perpendicularly to the streets on narrow plots, with façades facing the valley. Although they appear two-storied from the street, the terrain slope causes them to read as three or four stories from the valley side. Lower levels house service spaces such as stables, cellars, or storerooms, all physically connected to upper-level living

areas through vertical and horizontal circulation elements. Carved spaces may be attached behind, below, or alongside the masonry buildings, often integrated at different levels or separated by small courtyards. Additions and reinforcement walls introduced over time complicate the identification of original functions. Due to their microclimatic advantages, particularly constant humidity and temperature, many of these carved areas are still used for storage today. Isolated shelters located further from the core settlements often serve as barns or haylofts (Figure 9).

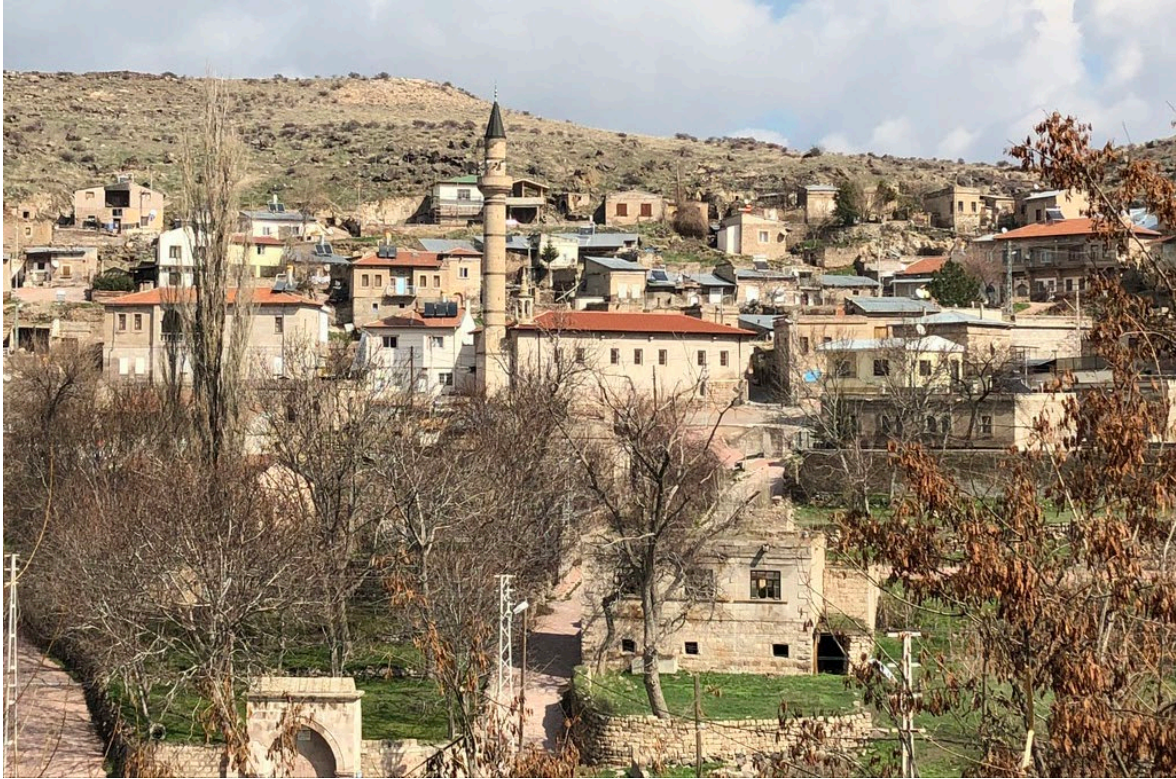
**Figure 10** Hillside settlement example from Bağpınar (Koramaz Valley)

Hillside settlements also provide insights into the evolution of morphology over time. Abandoned structures in Bağpınar and Vekse indicate earlier phases of expansion, while newer masonry buildings reflect subsequent growth. Present-day settlements now extend to the flat upper agricultural lands. In Ağırnas, however, former hillside areas have been almost entirely abandoned, with recent development concentrated on flatter terrain (Figure 10).

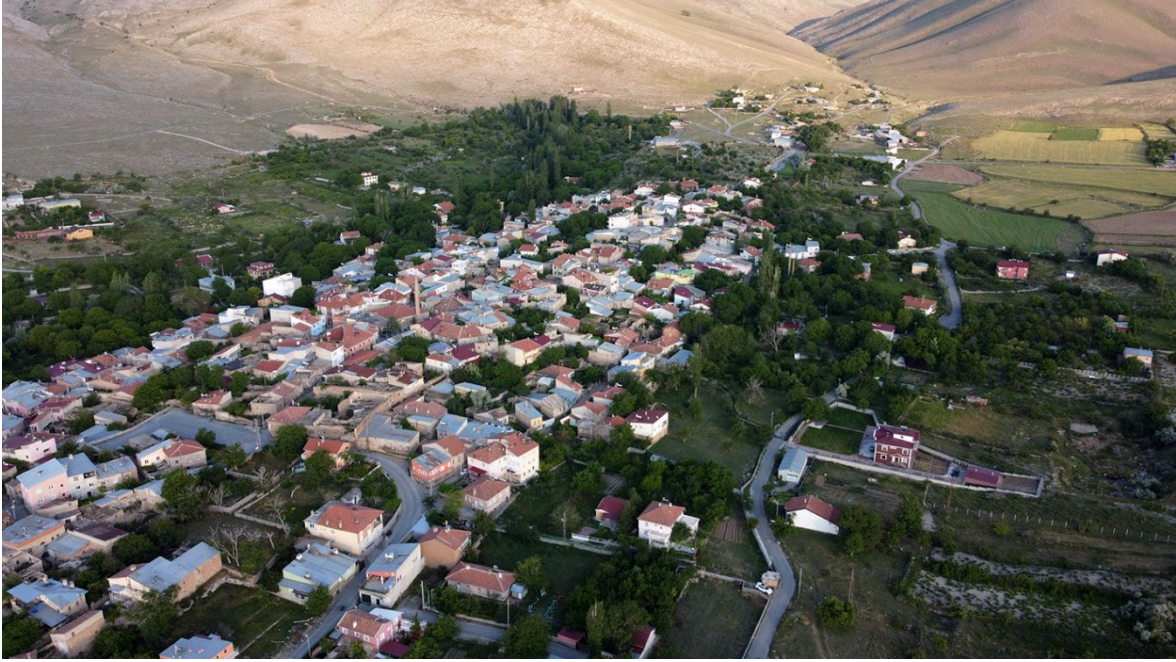
Plateau settlements, exemplified by Ağırnas and Büyükbürüngüz, are located in high and level areas and are closely associated with underground cities. Two-story stone masonry houses are arranged around large plots and courtyards, opening onto wide roads and squares. Unlike the shared gardens seen in hillside villages, each household in plateau settlements typically has its own private garden. Beneath these settlements, extensive underground spaces, sometimes reaching under homes, gardens, and roads, form expansive cave systems. Access is usually provided through vertical circulation shafts descending from courtyards or gardens. Masonry walls observed in these underground spaces suggest a subdivision pattern that reflects the above-ground parcel layout. However, there is no clear morphological continuity between underground and surface structures. Due to the lack of systematic documentation, most available data come from individual studies. Compared to the isolated, small-scale shelters found in hillside or basin contexts, the rock-cut spaces in Ağırnas and Büyükbürüngüz are larger, more complex, and more directly integrated with surface architecture (Figure 11).

Figure 11 Plateau settlement example from Büyükbürüngüz (Koramaz Valley)

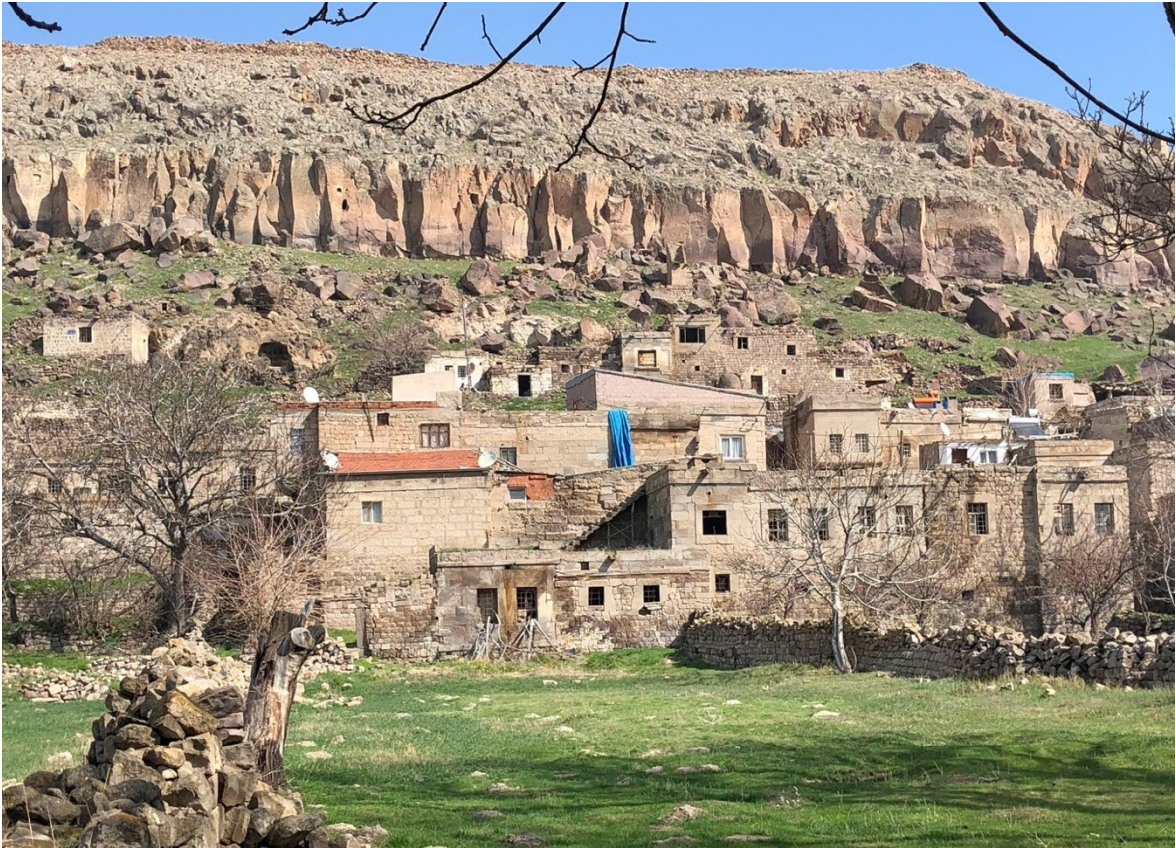
Figure 12 Basin settlement example from Mancusun (Gesi Valley)

Basin settlements, represented solely by Yeşilyurt, differ from the others due to their position at the lowest point of the valley, near water sources and gardens. Although the terrain is not completely flat, it is more gently sloped than elsewhere. In the upper parts of the village, narrow and deep plots are arranged along stepped streets, forming a dense and continuous urban fabric. In contrast, the lower sections feature broader, near-square plots with larger houses and extensive gardens. No integrated carved spaces are observed within the masonry fabric of basin settlements,

though isolated rock-cut shelters exist along the valley slopes, generally serving as storage or agricultural service areas (Elagöz Timur et al., 2018). Unlike hillside and plateau types, basin settlements show little to no direct relationship with rock-cut traditions (Figure 12).

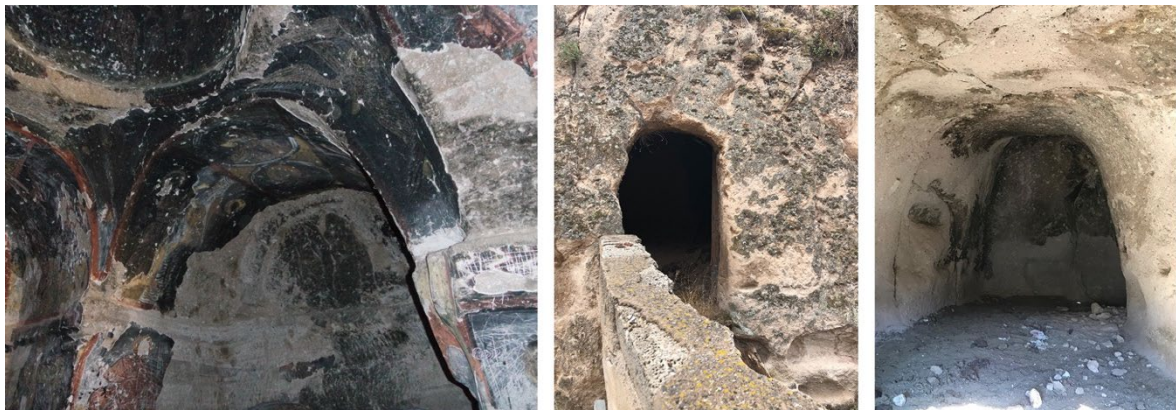
As discussed in Section II, the main conservation challenges affecting vernacular systems include physical deterioration, abandonment, loss of craftsmanship, depletion of material resources, and inappropriate interventions (Figure 13 and Figure 14). Fieldwork in the Kayseri valleys confirms the presence of all five, but in forms shaped specifically by the region's rock-cut construction logic and topography. Abandonment emerges as the most influential driver, triggering cascading effects such as reduced maintenance, structural exposure, and the erosion of craft knowledge.

Figure 13 Various deterioration due to the natural and human-induced effects

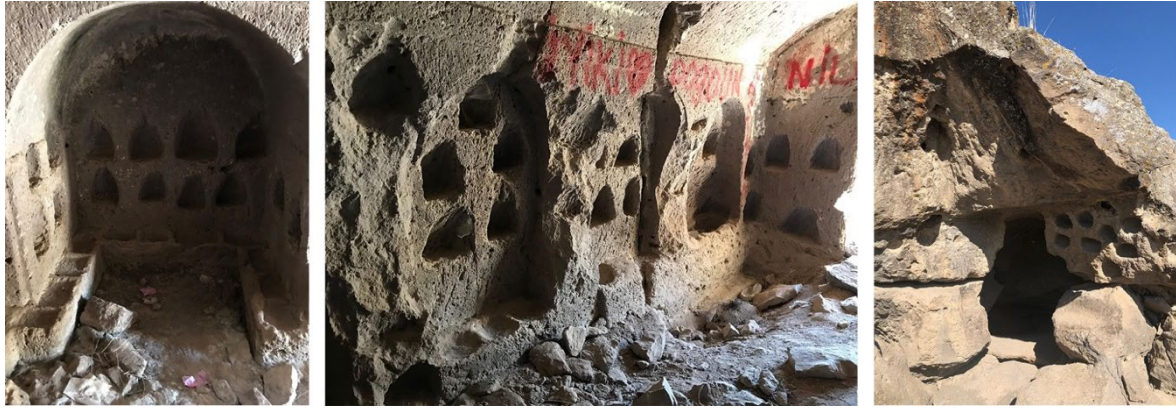
A second phase of abandonment has emerged as rock-cut structures have increasingly failed to meet modern living standards. Independent carved spaces are no longer in use, though hybrid structures combining masonry and rock-cut elements remain partially inhabited. Functional changes have also taken place: spaces used for production, religion, or residence were repurposed for animal husbandry or storage; rock-cut tombs became dovescotes (Yamaç, 2023). The later decline in pigeon breeding and bans on animal husbandry under urban reclassification led to further abandonment. Field observations indicate that fully carved units located on steep slopes with limited access are predominantly vacant, whereas hybrid structures on more accessible terraces continue to be used. These changes are reflected in physical traces such as blocked openings, soot accumulation, and surface abrasion, which provide direct spatial evidence of how changing use patterns have accelerated abandonment (Figure 15).

**Figure 14** Conservation problems due to the abandonment

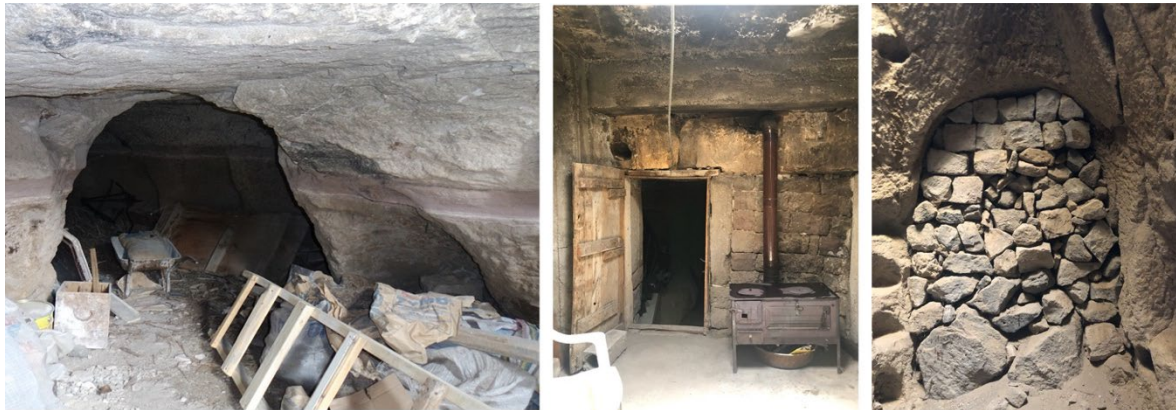
Rock-cut techniques, which have a unique construction logic and spatial organization, often conflict with modern needs (Elagöz Timur & Asiliskender, 2024). Although adaptive reuse has helped preserve them, unregulated modifications, such as subdividing or reinforcing weakened underground areas, have compromised archaeological integrity. Field observations reveal that such interventions are particularly evident in hybrid structures, where later masonry additions and infrastructural adjustments disrupt the original spatial continuity of carved spaces. Urban infrastructure projects, like road widening and heavy vehicle traffic, have caused collapses and uncontrolled infill (Figure 15).

**Figure 15** Inappropriate interventions
