# Rock-cut vernacular architecture in northeastern Kayseri: Architectural characteristics and conservation challenges

Bahar Elagöz Timur\*

Özlem Kevseroğlu Kurban\*\*

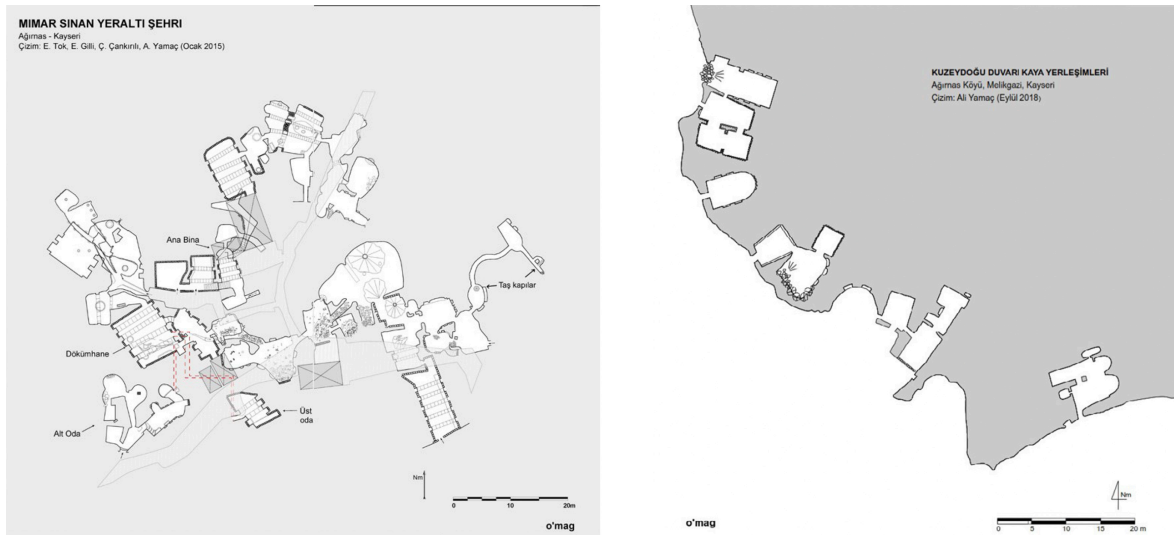
**Figure 2** Left: Ağırnas Mimar Sinan House underground city; by E. Tok, E. Gilli, Ç. Çankırılı, A. Yamaç (Ocak 2015), right: Ağırnas north-east hillside rock carving settlement; by A. Yamaç (Eylül, 2018) (Kayseri Büyükşehir Belediyesi, 2020)

As a prominent example, Ağırnas Underground City illustrates both the defensive function and the multi-layered nature of these rock-cut settlements (Figure 2). Covering an area of approximately 1,850 m<sup>2</sup>, it features sliding stone doors, barrel-vaulted halls, storage spaces, and multi-level living areas typical of Cappadocian underground architecture. Excavation and cleaning works carried out between 2006 and 2008 led to the restoration and partial opening of the site to visitors. Today, the sections that have been cleared are accessible to the public, while other parts remain either unexplored or still locally used. This site vividly reflects the historical continuity of rock-cut habitation in the region (Yamaç, 2017).

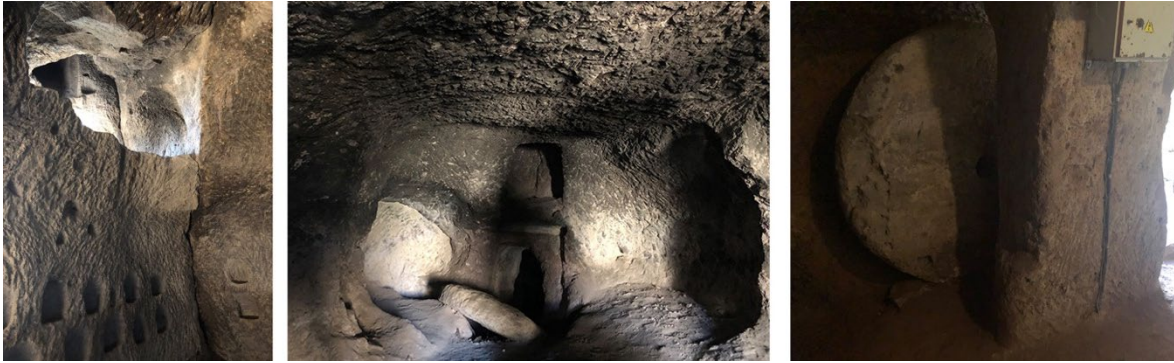
**Figure 3** Carving spaces under and back to the masonry houses (Bağpınar)

Spatially, these underground cities are organized into interconnected narrow passages and low tunnels that open into larger “salon” spaces, typically spread across two or three levels. Unlike hillside settlements, they have no facades visible from the surface and are accessed only through hidden entrances. Ventilation is provided through vertical shafts reaching the surface (Yamaç, 2023). Altogether, these underground complexes tell a vivid story of adaptation to defensive needs, life carved into the earth, and the layered coexistence of history within living settlement patterns (Figure 3).

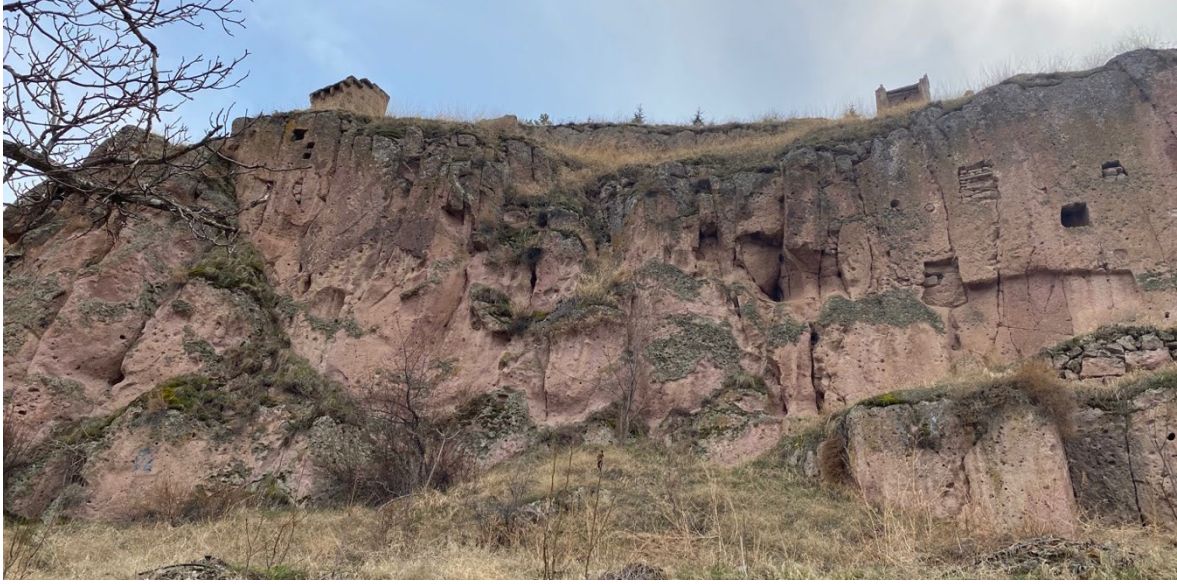
**Figure 4** Rock-cut hillside shelters examples from Vekse (Koramaz Valley)

Building on the typological framework outlined above, the second major formation seen in the valleys includes hillside settlements or shelters, which developed along the steep slopes typical of the study area. Carved into these inclines, they feature outward-facing facades and demonstrate how dwellings adapted to the rugged topography. The tradition of hillside settlement continued in a way that closely resembled the layout of today’s neighborhoods until recent times. For centuries, most valley villages have been built on steep terrain, where modern houses often sit atop earlier rock-cut spaces, making it difficult to interpret their original purposes. Unlike underground cities, hillside settlements rarely have extensive tunnel networks; instead, short passages connect only a few interior spaces, with entrances opening directly from the valley’s surface. These entrances are located at different elevations along the slopes, usually above watercourses and terrace gardens (Figure 4).

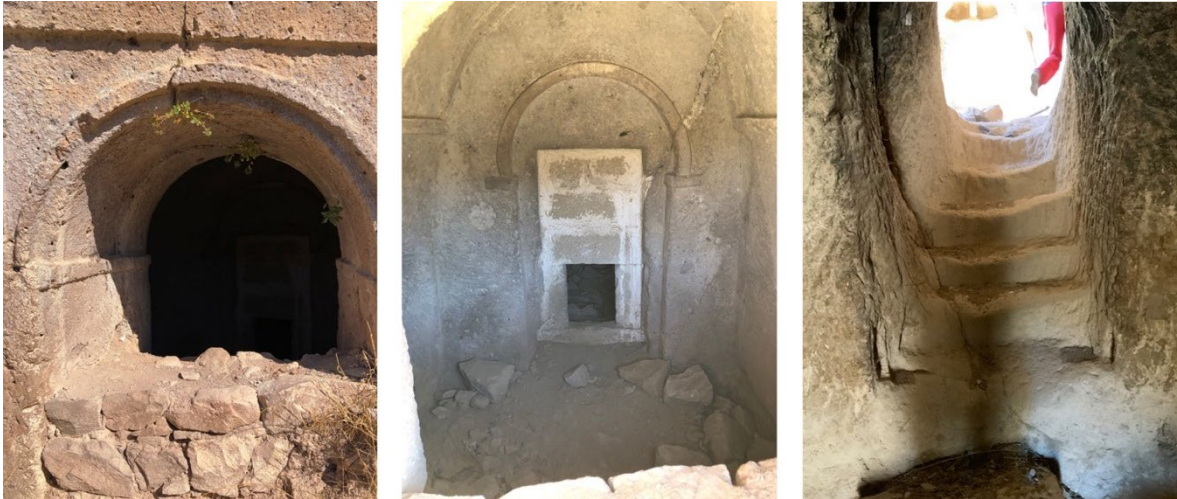
**Figure 5** Left and middle: Entrances of Değirmendere hillside rock carvings, right: Entrances of rock carving spaces (Bağpınar)

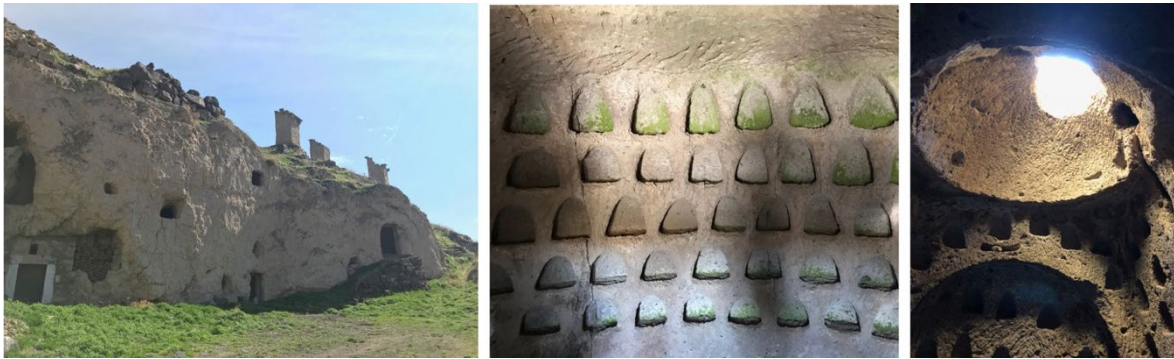
Figure 6 Yeşilyurt (Mancusun) dovecotes, middle: Inside of dovecote, right: A changed carving space as dovecote (Kayabağ)

One of the most common structures in the valleys is the dovecote. Unlike similar examples elsewhere in Anatolia, these pigeon lofts evolved locally as specialized production structures adapted to the region's environmental and socio-economic conditions (Figure 6). They provide insights into agriculture, trade, and daily life during the Ottoman period, particularly through their association with vineyards and buckthorn cultivation, when dove manure had notable economic value (İnceköse, 2019). As water availability declined, pigeon breeding ceased, and the structures were abandoned, becoming prominent cultural landscape markers, especially in Gesi and Koramaz Valleys. Architecturally, dovecotes combine carved chambers with stone-masonry chimneys serving as bird entrances. Many former rock-cut spaces, including churches, Roman tombs, and columbaria, were later converted into dovecotes, complicating dating efforts and obscuring stratigraphic evidence (Yamaç, 2023).

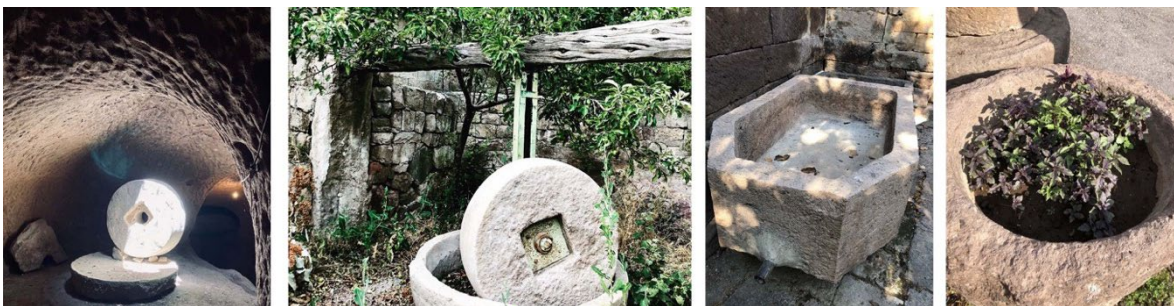
Figure 7 Left to right: Oil mill (Bezirhane), vertical millstone (Seten), stone basin (Sirahane), stone mortar (Soku)

Documentation studies also addressed daily-use objects shaped from rock, illustrating the adaptation of natural resources to local production (Figure 7). These include animal-husbandry structures (barns, stables), plant-based facilities (dye houses, oil mills), and carved agricultural tools. Bezirhane processed linseed oil for food, lighting, and craft uses, while şirahane served as communal sites for molasses making. Tools such as seten (vertical millstone), soku (stone mortar), and dorak (dairy container) supported grain milling and dairy processing, reflecting how subsistence practices shaped rock-carving traditions (Kevseroğlu et al., 2021).

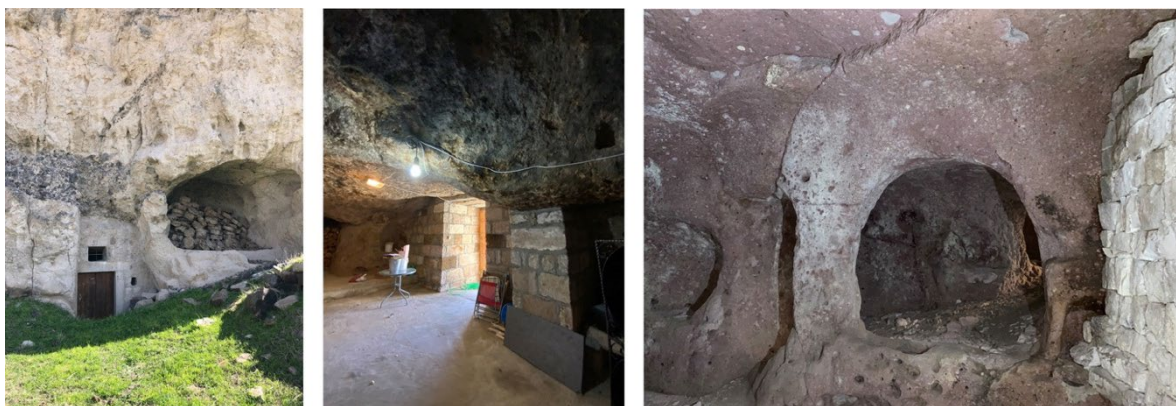
Figure 9 Hillside shelter rock-cut settlement relationship

Hillside settlements exhibit a morphology that extends the tradition of rock-cut slope dwellings. Contemporary masonry houses are built atop or adjacent to earlier carved spaces, resulting in a hybrid typology. These houses often incorporate “in” spaces, rock-cut units, independent or shared, divided by masonry walls. Cubic masonry structures are aligned perpendicularly to the streets on narrow plots, with façades facing the valley. Although they appear two-storied from the street, the terrain slope causes them to read as three or four stories from the valley side. Lower levels house service spaces such as stables, cellars, or storerooms, all physically connected to upper-level living

areas through vertical and horizontal circulation elements. Carved spaces may be attached behind, below, or alongside the masonry buildings, often integrated at different levels or separated by small courtyards. Additions and reinforcement walls introduced over time complicate the identification of original functions. Due to their microclimatic advantages, particularly constant humidity and temperature, many of these carved areas are still used for storage today. Isolated shelters located further from the core settlements often serve as barns or haylofts (Figure 9).

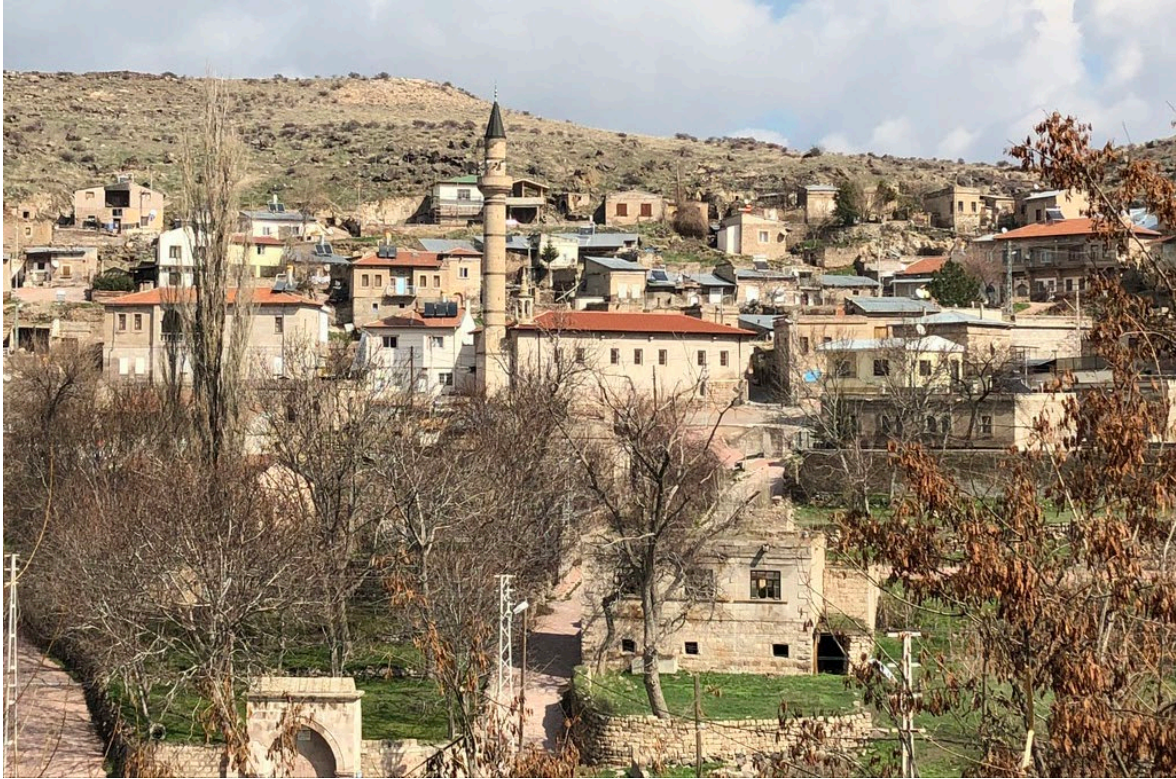
**Figure 10** Hillside settlement example from Bağpınar (Koramaz Valley)

Hillside settlements also provide insights into the evolution of morphology over time. Abandoned structures in Bağpınar and Vekse indicate earlier phases of expansion, while newer masonry buildings reflect subsequent growth. Present-day settlements now extend to the flat upper agricultural lands. In Ağırnas, however, former hillside areas have been almost entirely abandoned, with recent development concentrated on flatter terrain (Figure 10).

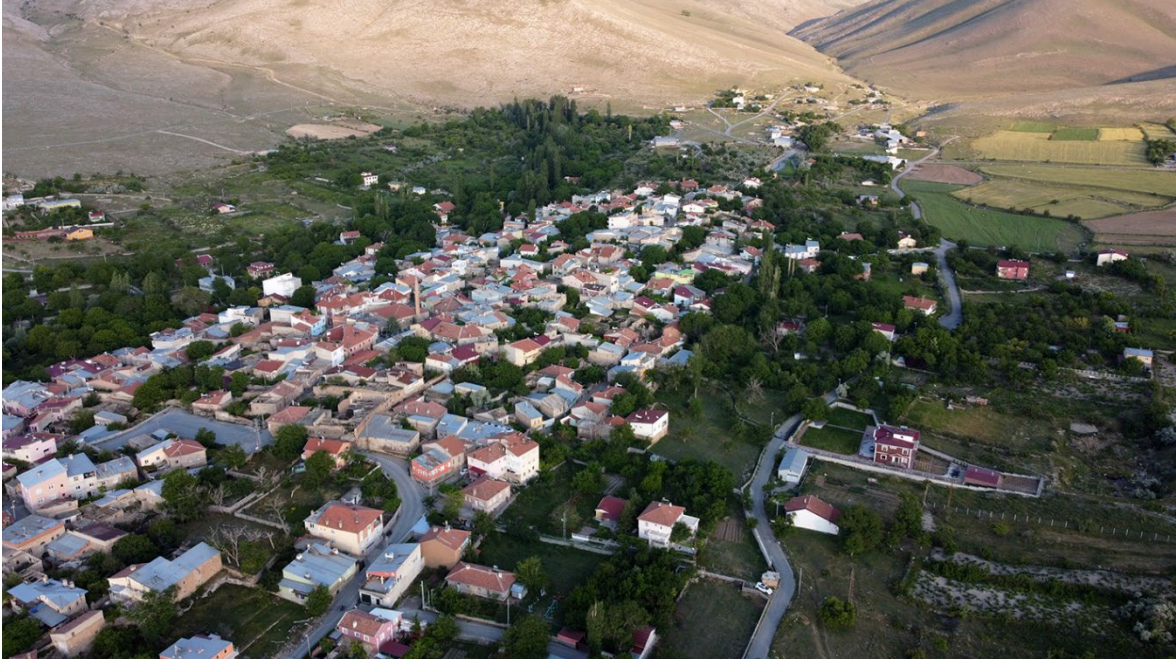
Figure 11 Plateau settlement example from Büyükbürüngüz (Koramaz Valley)

Plateau settlements, exemplified by Ağırnas and Büyükbürüngüz, are located in high and level areas and are closely associated with underground cities. Two-story stone masonry houses are arranged around large plots and courtyards, opening onto wide roads and squares. Unlike the shared gardens seen in hillside villages, each household in plateau settlements typically has its own private garden. Beneath these settlements, extensive underground spaces, sometimes reaching under homes, gardens, and roads, form expansive cave systems. Access is usually provided through vertical circulation shafts descending from courtyards or gardens. Masonry walls observed in these underground spaces suggest a subdivision pattern that reflects the above-ground parcel layout. However, there is no clear morphological continuity between underground and surface structures. Due to the lack of systematic documentation, most available data come from individual studies. Compared to the isolated, small-scale shelters found in hillside or basin contexts, the rock-cut spaces in Ağırnas and Büyükbürüngüz are larger, more complex, and more directly integrated with surface architecture (Figure 11).

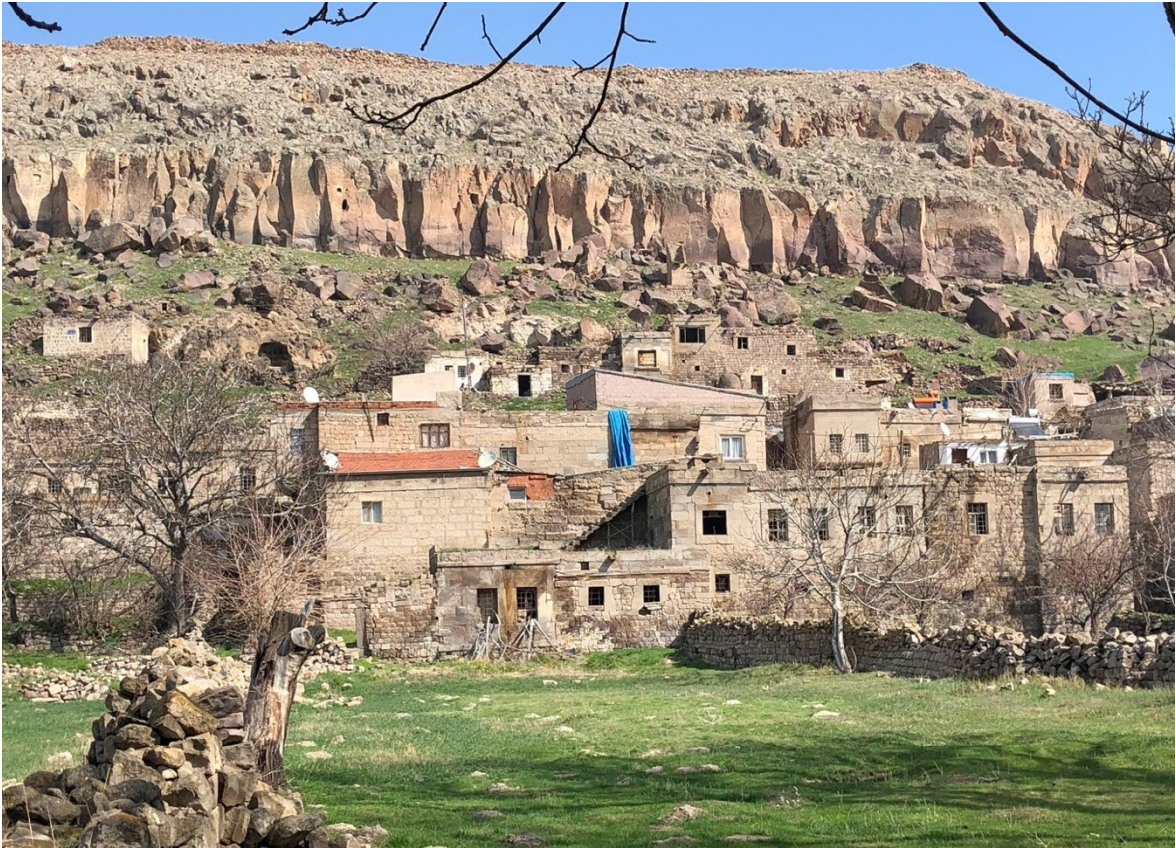
Figure 12 Basin settlement example from Mancusun (Gesi Valley)

Basin settlements, represented solely by Yeşilyurt, differ from the others due to their position at the lowest point of the valley, near water sources and gardens. Although the terrain is not completely flat, it is more gently sloped than elsewhere. In the upper parts of the village, narrow and deep plots are arranged along stepped streets, forming a dense and continuous urban fabric. In contrast, the lower sections feature broader, near-square plots with larger houses and extensive gardens. No integrated carved spaces are observed within the masonry fabric of basin settlements,

though isolated rock-cut shelters exist along the valley slopes, generally serving as storage or agricultural service areas (Elagöz Timur et al., 2018). Unlike hillside and plateau types, basin settlements show little to no direct relationship with rock-cut traditions (Figure 12).

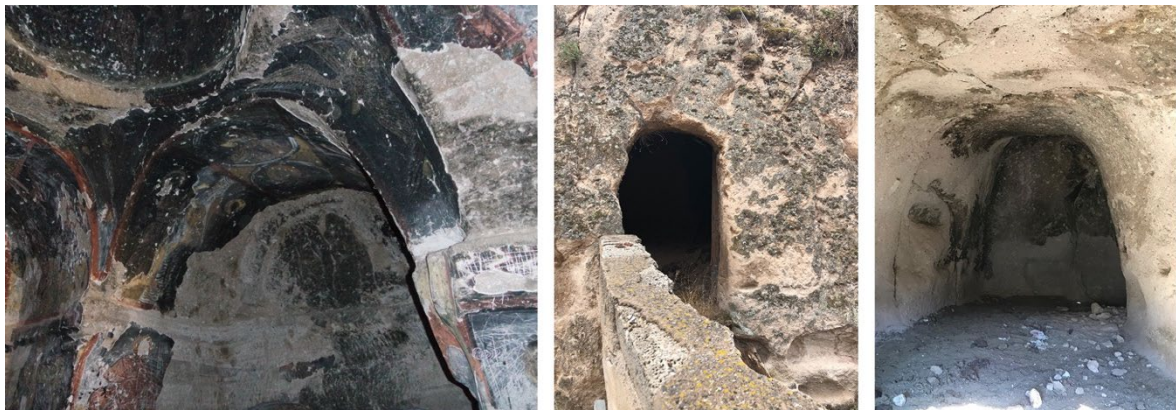
Figure 13 Various deterioration due to the natural and human-induced effects

As discussed in Section II, the main conservation challenges affecting vernacular systems include physical deterioration, abandonment, loss of craftsmanship, depletion of material resources, and inappropriate interventions (Figure 13 and Figure 14). Fieldwork in the Kayseri valleys confirms the presence of all five, but in forms shaped specifically by the region's rock-cut construction logic and topography. Abandonment emerges as the most influential driver, triggering cascading effects such as reduced maintenance, structural exposure, and the erosion of craft knowledge.

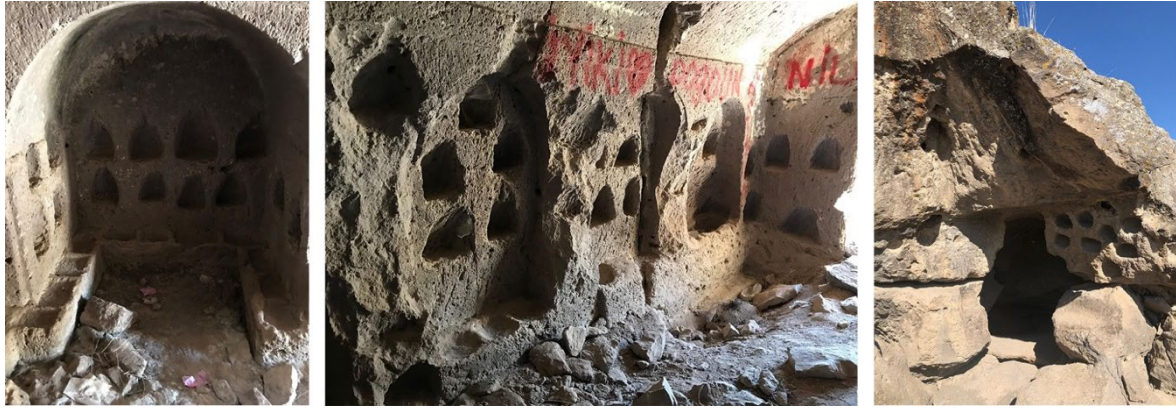
Figure 14 Conservation problems due to the abandonment

A second phase of abandonment has emerged as rock-cut structures have increasingly failed to meet modern living standards. Independent carved spaces are no longer in use, though hybrid structures combining masonry and rock-cut elements remain partially inhabited. Functional changes have also taken place: spaces used for production, religion, or residence were repurposed for animal husbandry or storage; rock-cut tombs became dovecotes (Yamaç, 2023). The later decline in pigeon breeding and bans on animal husbandry under urban reclassification led to further abandonment. Field observations indicate that fully carved units located on steep slopes with limited access are predominantly vacant, whereas hybrid structures on more accessible terraces continue to be used. These changes are reflected in physical traces such as blocked openings, soot accumulation, and surface abrasion, which provide direct spatial evidence of how changing use patterns have accelerated abandonment (Figure 15).

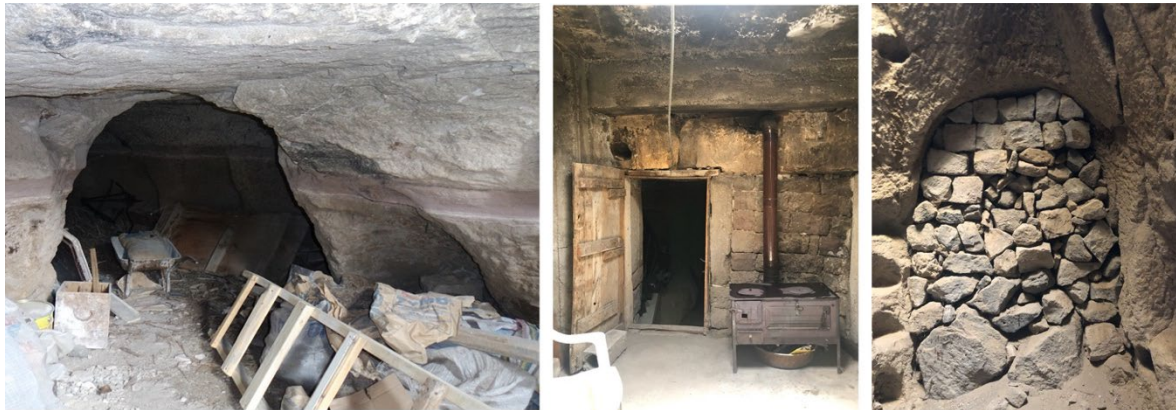
Figure 15 Inappropriate interventions

Rock-cut techniques, which have a unique construction logic and spatial organization, often conflict with modern needs (Elagöz Timur & Asiliskender, 2024). Although adaptive reuse has helped preserve them, unregulated modifications, such as subdividing or reinforcing weakened underground areas, have compromised archaeological integrity. Field observations reveal that such interventions are particularly evident in hybrid structures, where later masonry additions and infrastructural adjustments disrupt the original spatial continuity of carved spaces. Urban infrastructure projects, like road widening and heavy vehicle traffic, have caused collapses and uncontrolled infill (Figure 15).
